## Determination 2019/058

# Regarding the durability of steel sub-floor bearers installed in four houses that have been built in respect of building consents issued on the basis of national multiple-use approvals

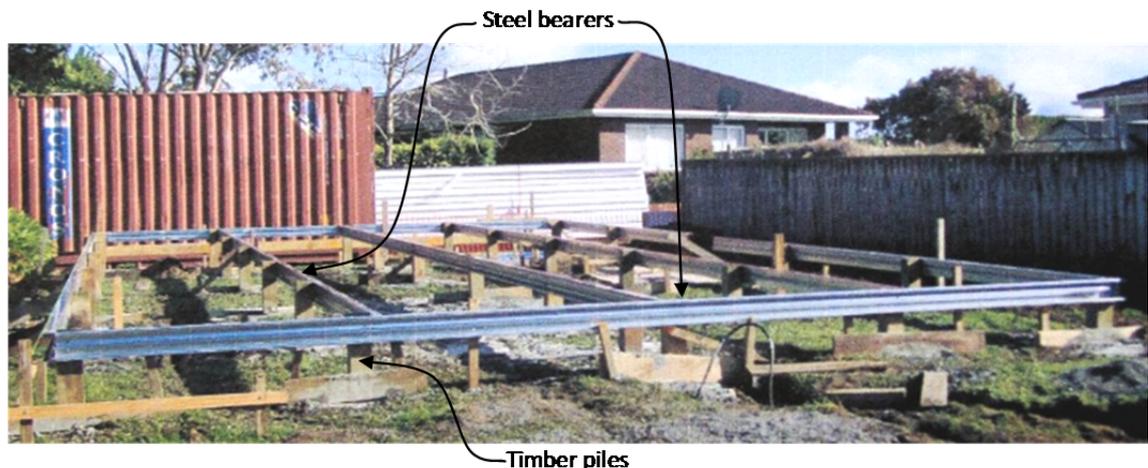
**Figure 2: Typical sub-floor construction for all four buildings**

2.3.1 The following photograph shows the piles and the galvanised steel bearers during construction of a prefabricated house on a level site.

2.3.2 Clearance from the underside of the SIPs floor structure to the ground is typically 450mm, with 300mm clearance below the galvanised steel bearers. The sub-floor crawl space is enclosed with corrugated steel cladding, with a minimum 40mm gap provided at the bottom for ventilation of the sub-floor as shown in Figure 3.

- when a purlin C-section is used as a bearer, its durability is compromised as its bottom flange can collect debris and condensed moisture, with the inspection photographs showing both building debris and speckle rust on installed steel bearers

- evidence of rusting so early in the life of the building suggests that sections were not adequately cleaned of non-visible salt contaminants before priming

- bottom of C-sections with rust, timber swarf and debris
  - other areas with surface rust, which was later painted over
  - bearers had been touched up ‘by spraying over the rust that could be reached via the limitation of the crawl space and limited accessibility to the entire beam.’

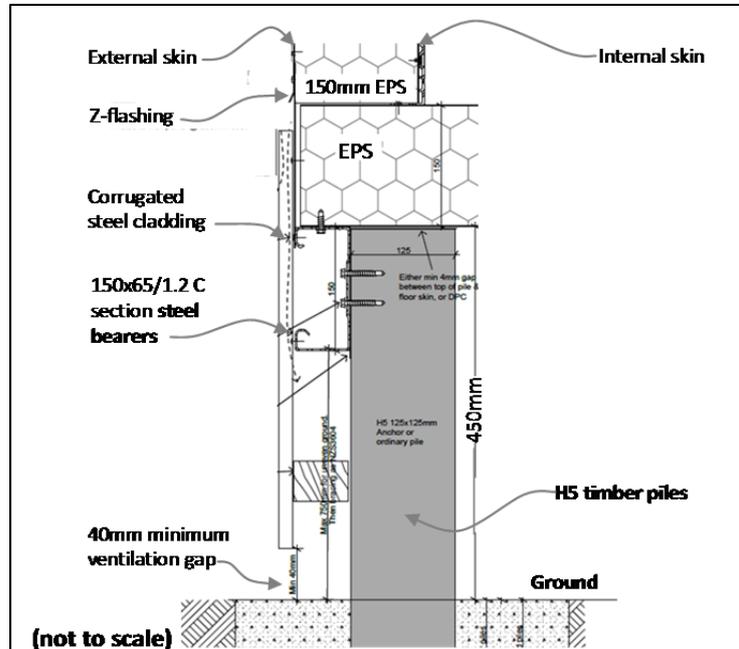
Figure 3: The sub-floor construction

Purlins in sub floor space - to be read in column 8 [from the table in Appendix B2.1] - Internal & High humidity

- In regard to the deck detail:
  - the outer perimeter steel bearer is exposed to moisture below the deck from rainwater, resulting in partial ponding on its bottom flange
