Determination 2023/037

The compliance of a waterproof membrane tanking system with Clause E2 of the Building Code

8 Rock Hill Drive, Kennedys Bush, Christchurch

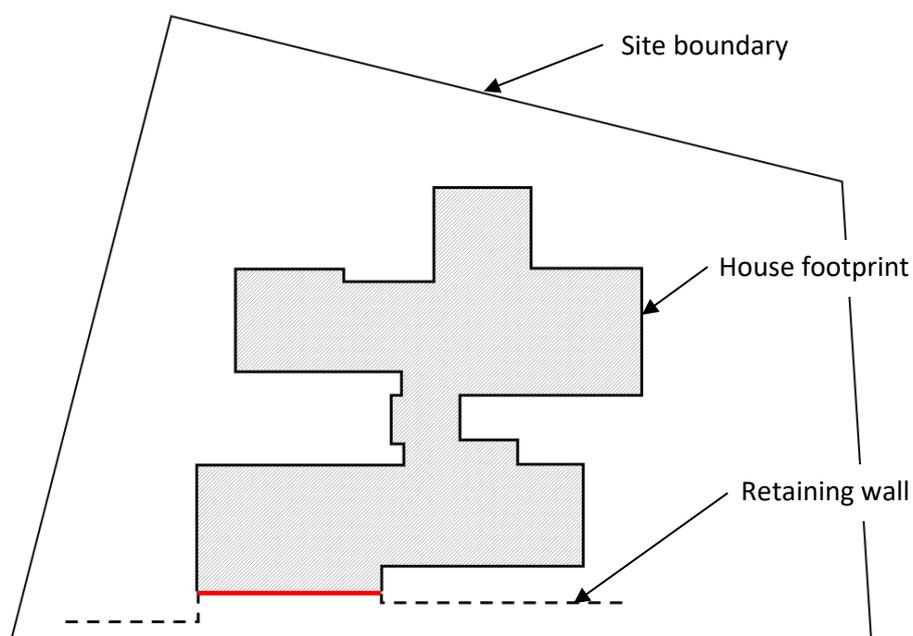
- 2.3. The building includes a blockwork retaining wall that roughly follows the southern boundary of the proper. The retaining wall also forms part of the southern wall of the garage, shown in figure 1 below.

Figure 1. Diagram showing the site layout. The portion of the retaining wall in question is highlighted in red.

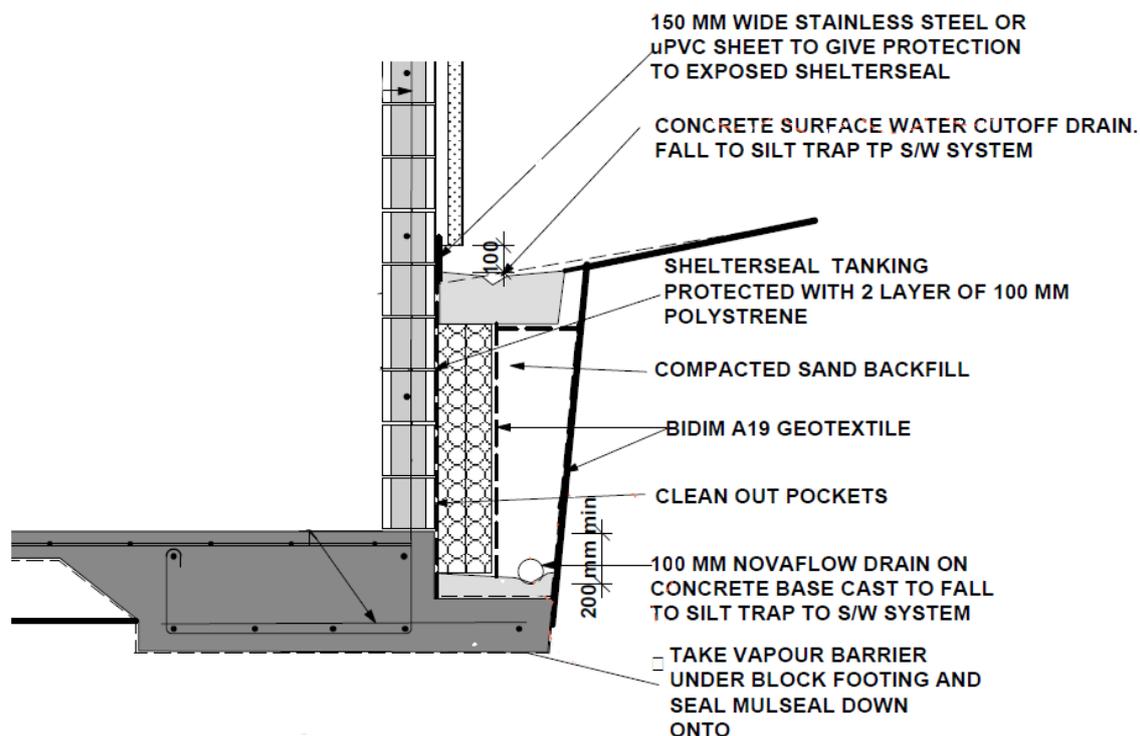
Figure 2. Excerpt from approved plans showing construction detail for the tanking system.

- 5.9. These requirements for the tanking system are reflected on the consented plans (refer to figure 2).
- 5.10. It is not in dispute between the parties that the tanking system, as documented in the appraisal and the consented plans, would comply with the requirements of Clause E2.3.3 if installed in accordance with the requirements set out in this documentation.
