Determination 2017/075

Regarding the code-compliance of decks to a house at 9 Adamson Road, Taipa

This determination considers the compliance of a deck to wall junction with minimal or no gap. The determination discusses the weathertightness risk and whether the cladding is likely to be subject to solar-driven moisture from the deck, and the variation from the building consent.

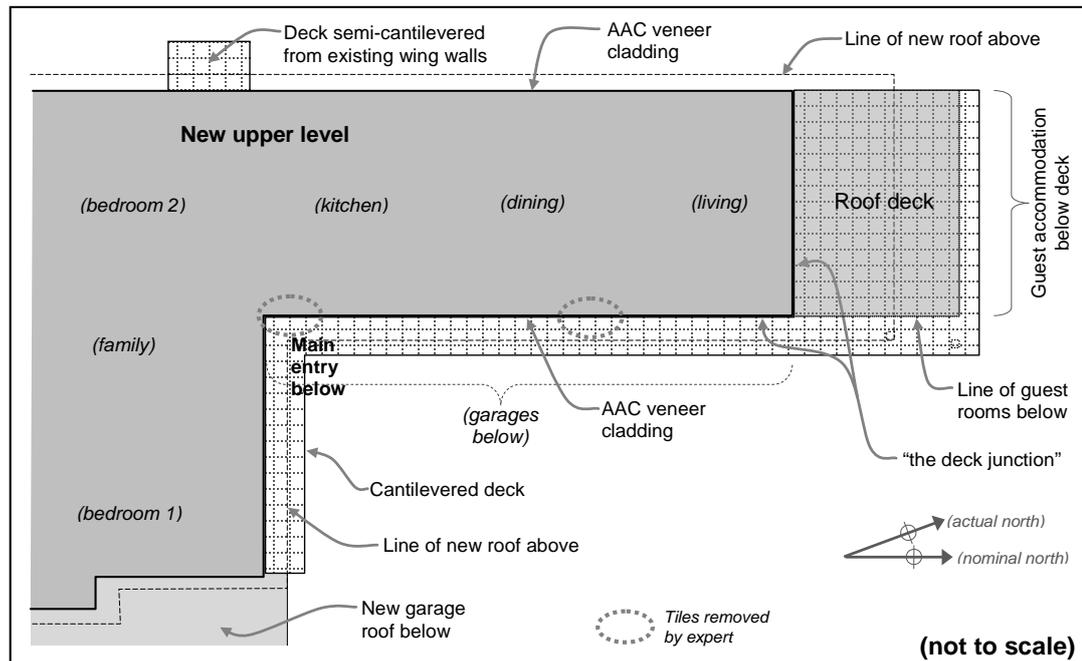
Figure 1: Approximate deck plan

2.6.1 The upper level deck consists of a north roof deck which extends as a cantilever above the garage doors and along the north face of the east wing as shown in Figure 1.

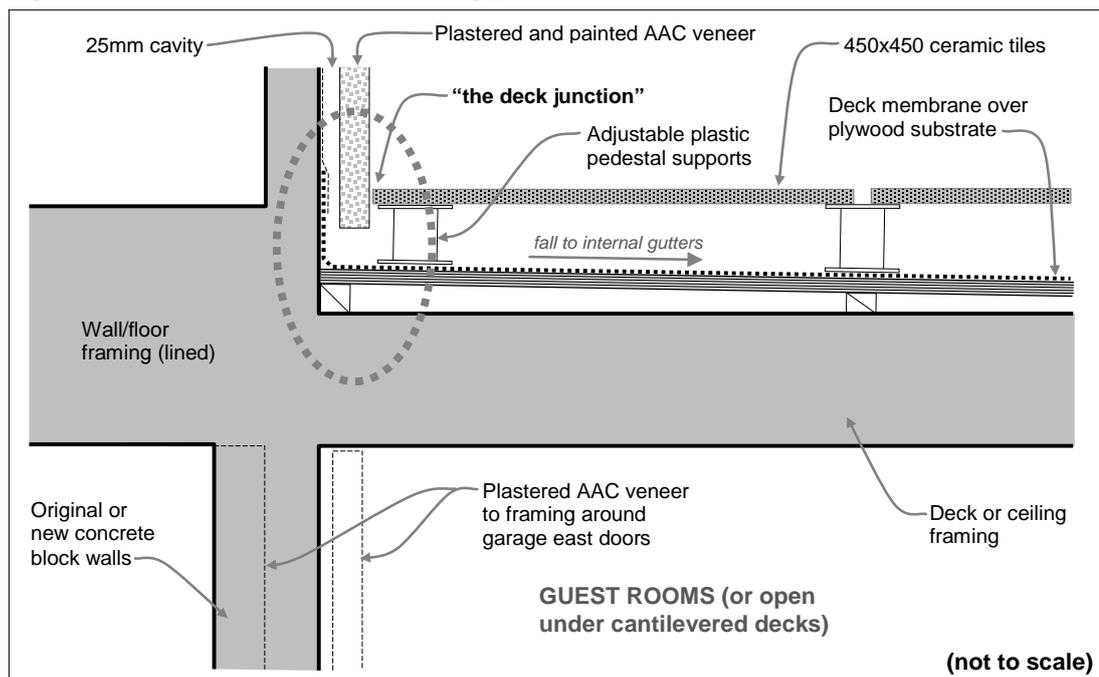
Figure 2: As-built deck to cladding junction

2.6.3 The deck to wall cladding junction as constructed is shown in Figure 2. Although the designer maintained that spacers provide a 5 to 7mm gap at the junction, the expert observed no gap on the east elevation and a small gap on the north elevation. At the glazed doors a 50 x 20mm aluminium angle is installed at the threshold, with the 20mm leg overlapping the edge of the deck tile.

4.2.2 The expert observed no gap at the east elevation deck junction and a small gap on the north elevation. The expert removed two deck tiles from the northeast internal corner of the deck (see Figure 1) to view the underlying construction, and noted:

- construction was as described in the drawings, with adjustable plastic pedestals supporting the ceramic tiles
- the underside of the tiles embossed with the proprietary name, and the product is specified by the tile manufacturer as porcelain with absorption of 0.5% or below
- the AAC panels are installed over a cavity, with:
 - drainage slots in the cavity base extrusion
 - the coating system applied to the base of the panels below the tile level
- a silicone spacer adhered to the tile edge at the junction of the north elevation, with a small accumulation of sand blown through the small gap
- a small accumulation of debris at the tile edges to the east elevation where tiles were butted against the cladding.

...asked for the deck tiles next to the building exterior cladding to be cut to provide a 12mm gap as per the building consent plans. To provide a 12mm space between deck tile and exterior building wall.
