Report to the Residential Engineering Advisory Group

Condition of polythene DPM under cracks in concrete floor slabs

G J Beattie

8 August 2012

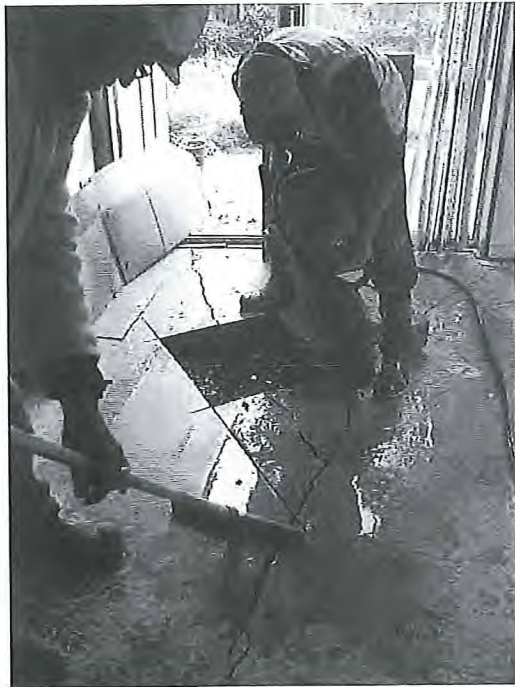
Cutting second panel (dining area)

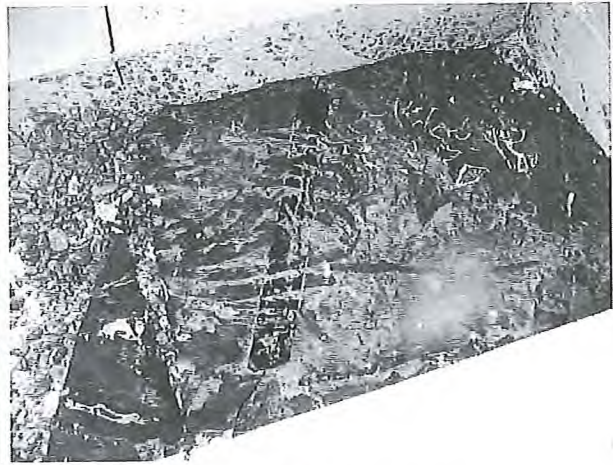
The taped joint appeared to be reasonable sound still. The tape was not continuous but it may have pulled off the DPM locally as the saw cut through it.

Taped joint exposed (dining area)

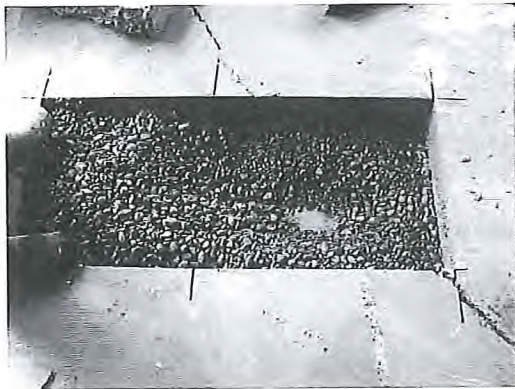
The hardfill beneath the DPM was also inspected at each location. It was found that both houses had hardfill that comprised stones between 10 mm and 20 mm in diameter. There was no immediately obvious evidence of silt-sand penetration of the hardfill even though there was considerable ejecta around the outside of the houses. When the hardfill in the garage at [REDACTED] was excavated, wet silty sandy material was found in the stones at about 25mm depth. The stones were quite clean above this level, suggesting that the contamination was from ejecta below the slab. At both of the other locations no contamination was observed until about 100 mm below the underside of the slab.

Water welled up to 100mm below the slab

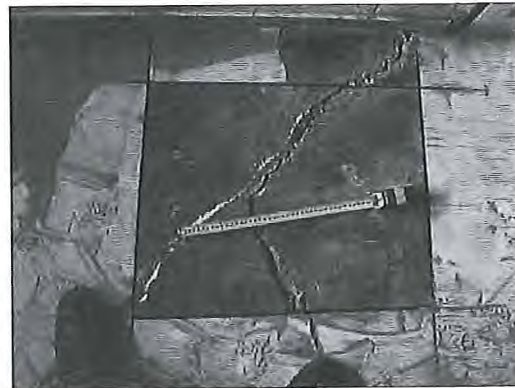
Panel in bathroom at (Crack had been filled with expanding foam)

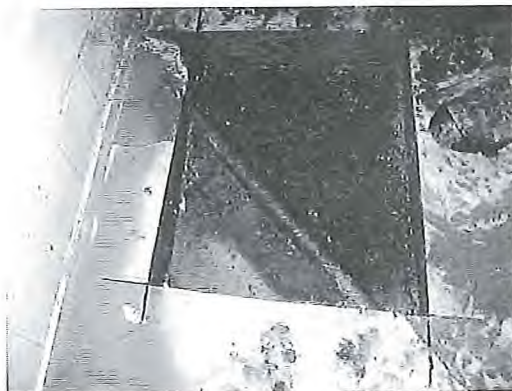
The 30 mm wide crack at [REDACTED] formed because the concrete thickness had reduced to approximately 80 mm to accommodate a waste pipe from a hand basin, that was wrapped in a greased lagging (probably Densotape) and which sat only half of its depth into the hardfill. The local reduction in slab thickness had obviously been the greatest weakness in the slab as the house tried to stretch laterally.

Waste pipe beneath slab (Bathroom)

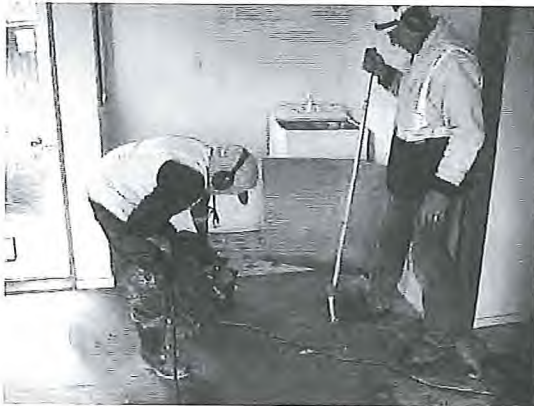
Cutting the garage floor [redacted]

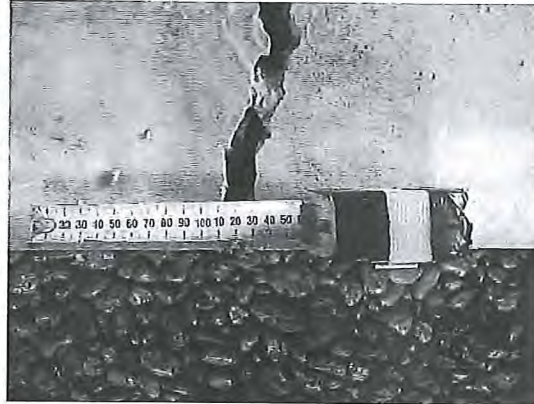
Crack width and stone size [redacted] garage)

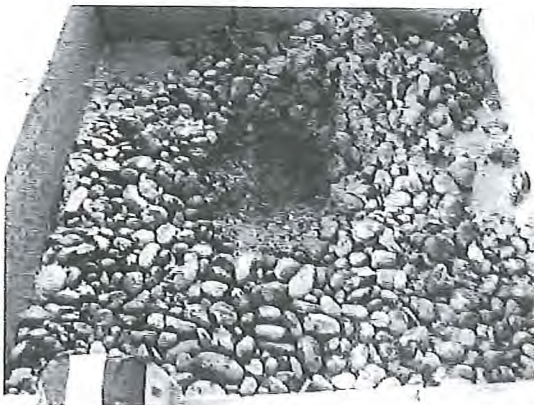
Hardfill contamination [redacted] garage)

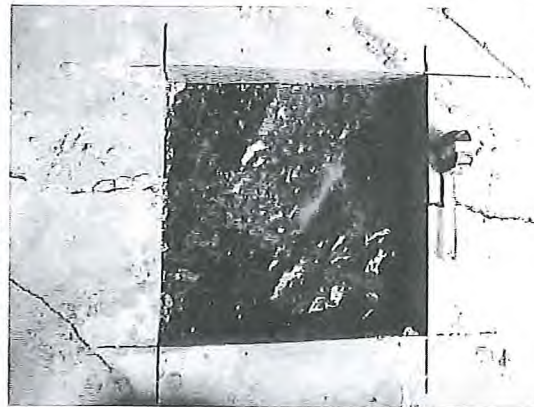
A careful inspection of the DPM removed from the three locations in the two houses showed that there appeared to be no damage to the DPM caused by the cracking and opening of the floor slab for cracks up to 30mm wide. For cracks any wider than 30 mm it would be possible check the integrity of the DPM by inspection through the crack opening. All sections of DPM were brought back to BRANZ for closer inspection (once cleaned of silt and cutting slurry), where they were placed on a light-table. This showed that there were pin hole penetrations caused by workmen walking on the DPM once in place before pouring the concrete but there were no signs of reduction of the thickness caused by local stretching. It was figured that such a stretch would make the film more easily penetrable by the light.

Exposed DPM [redacted] dining area)

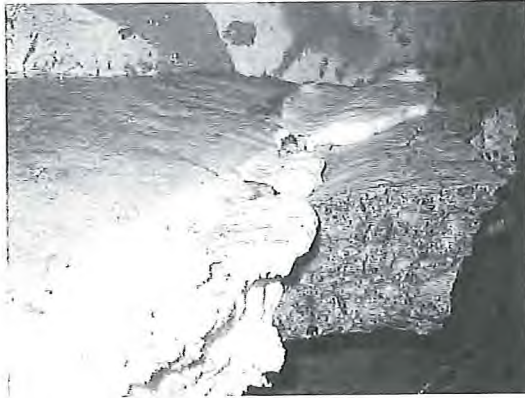
Reduction in slab thick filled with foam [REDACTED]

(Slab section is inverted for the photograph)
