Weathertightness of an infill wall-column junction

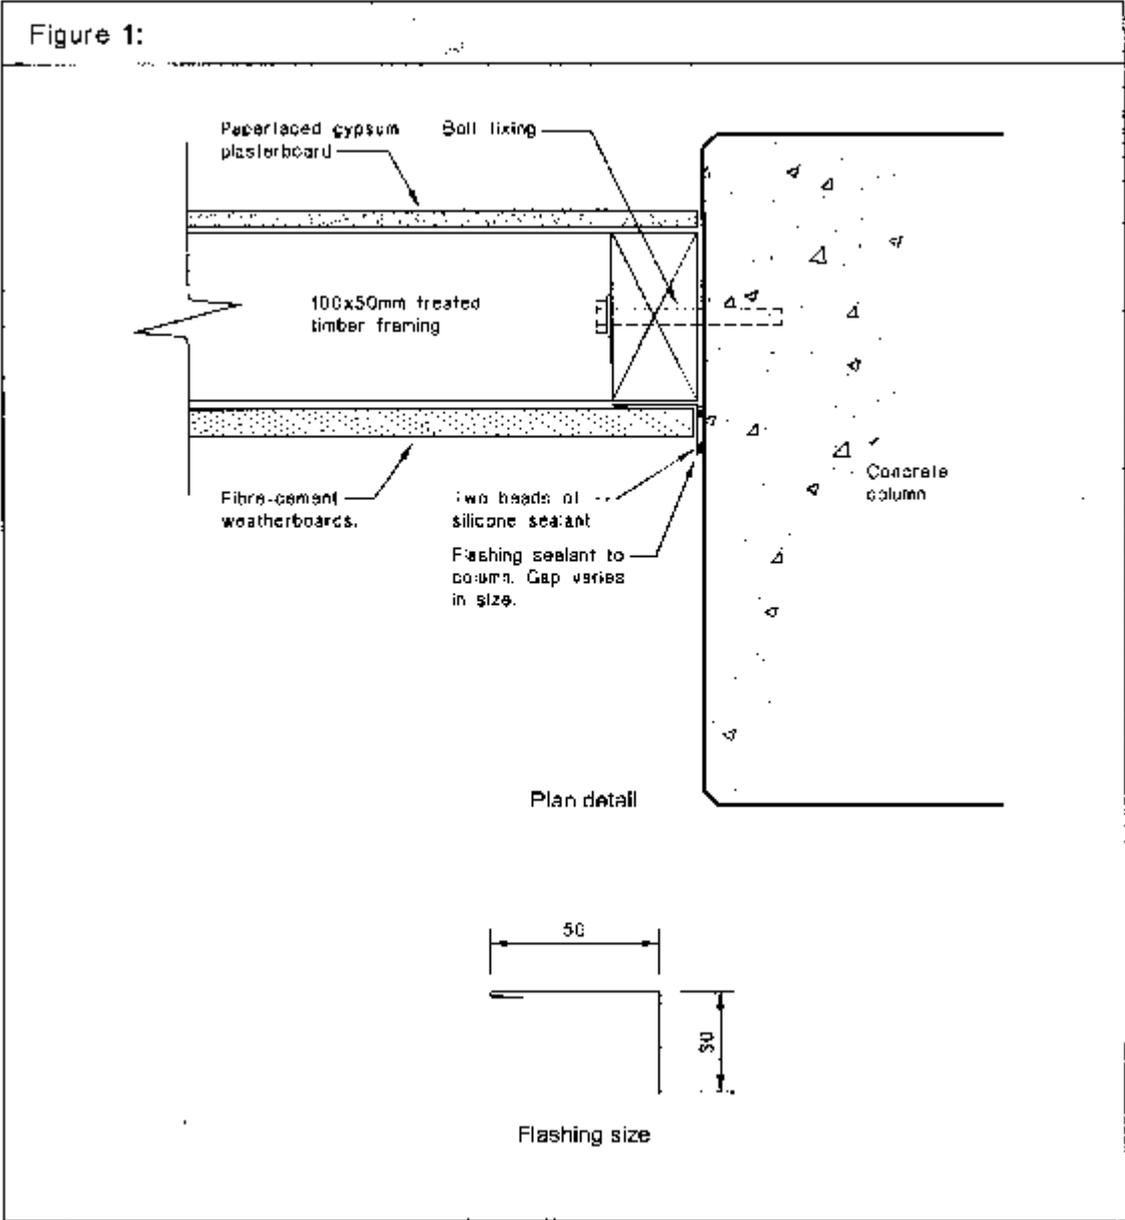
SubmissionFIG1.dwg 040303

- 3.1 The infill wall was installed in the course of alterations to an existing building owned by the territorial authority.
- 3.2 The infill wall consists of treated timber framing with fibre-cement weatherboards on the exterior face and paper-faced gypsum plasterboard on the interior face. The junctions between walls and columns are as shown in Fig. 1 (which has been prepared from the applicant’s and the builder’s submissions).
- 3.3 The territorial authority’s community facilities section was uncertain about the junction as installed, while the construction contracts administration section was not satisfied that it complied with the building code and applied for this determination.

. . . I believe for a number of reasons that the flashing detail that has been installed will fail. I comment as follows:

The joint is reliant on a sealant to

- waterproof the junction to the flashing and concrete column
- act as a gap filler since the flashing is not in continuous contact with the column. . . .

There is no evidence of any second line of defence against the ingress of moisture . . .

Given that in general, the flow of water at vertical joints is much greater than the average flow of water over the wall, even if the flashing was well secured and waterproofed to the flashing/column junction water will get behind the ends of [the fibre-cement weatherboards]. The other concerns that I have [include]:

given the way in which the ends of [the fibre-cement weatherboards] have been fitted to or near the flashing, gives rise to "wicking" of moisture through the end and back of [the fibre-cement weatherboards]. Fibre cement as a material is prone to such a problem to a greater extent than many other cladding materials. . . .

6.2 The Authority notes that the junction does not comply with the manufacturer's data in respect of a filler rod, and that the exterior bead of sealant is exposed to sunlight and weather, contrary to paragraph 3.1.1 of E2/AS1.
