Effect of fixings on the performance of timber weatherboards

1 THE MATTERS TO BE DETERMINED

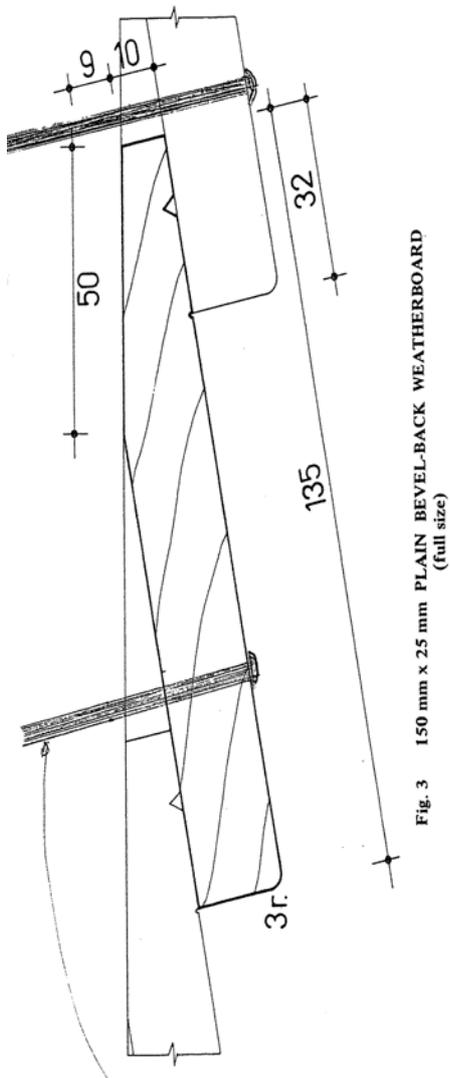
Single nail (75mm x 3.15mm) per board shall be located immediately above, but within 10mm of the top

**SINGLE NAIL FIXING
AS REQUIRED BY NZS 3604***
(figure received from Territorial Authority)

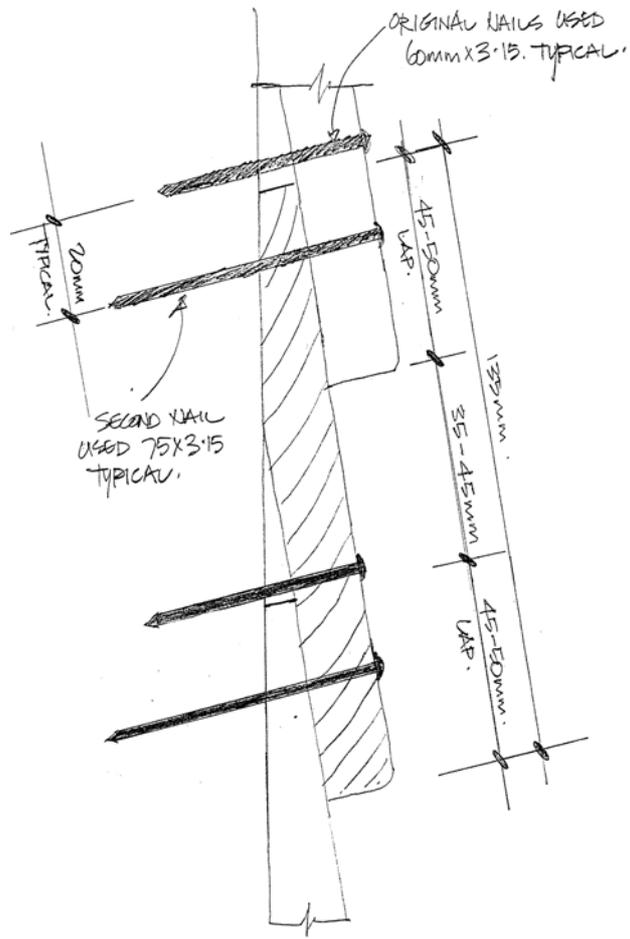
**THREE NAIL FIXING
AS INSTALLED**
(figure received from owner)

- 5.1 The territorial authority said:
“Movements due to temperature and moisture are effectively restrained as a result of three point fixings. We are unsure of the long-term effects on the performance of weatherboards due to fixing and are unable to accept as code complying.”

- “(a) If significant drying and splitting from shrinkage was going to occur, there would be evidence of that by now. However there was no evidence of splitting present, and only mild cupping.
- “(b) There is potential for perhaps another 3% drying, at worst, and that is unlikely to bring about serious and extensive failure.
- “(c) If further drying did cause splitting, then this is likely to be limited in extent, would be readily noticeable and could be attended to as maintenance before any more consequential failure occurred. . . .
- “(d) In my opinion, in this particular situation, it is unlikely that the unconventional nailing of the weatherboards will bring about a failure to comply with the performance requirements of the N Z Building Code but this opinion remains valid only if the issues listed below are addressed.”

- (a) Determines that, in this particular case, the fixing of the weatherboards is such that the exterior wall complies with clause E2.3.2 of the building code.
- (b) Reverses the territorial authority's decision to refuse to issue a code compliance certificate in respect of the fixing of the weatherboards.
