## Determination 2008/108

### Refusal to issue a code compliance certificate for an addition to a motel at 66 Trafalgar Street, Nelson

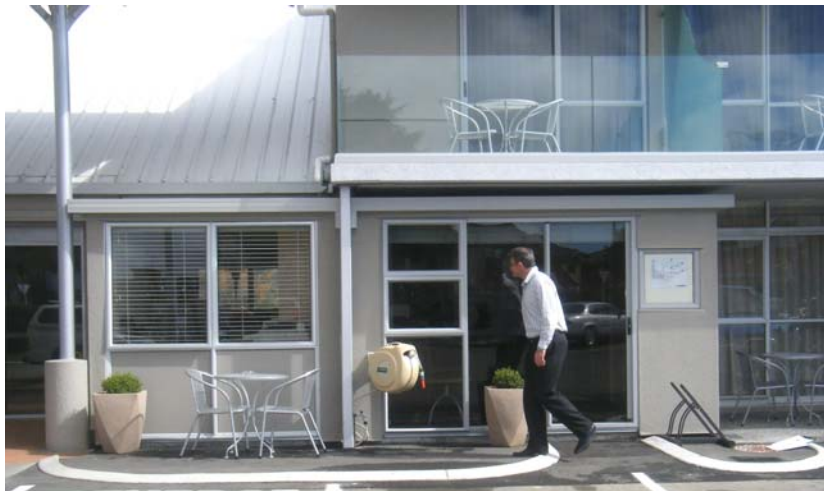
2.1 The building work consists of a small addition and associated alterations to a detached motel building situated on a flat urban site, which is in a low wind zone for the purposes of NZS 3604<sup>3</sup>. The addition is small, being only about 7.5m<sup>2</sup> in plan area, and extends the reception and office areas adjacent to the main entry on the north elevation. The associated interior alterations include the replacement of several partitions to suit the new reception and office area layout.

2.2 The addition is conventional timber frame construction, with a concrete slab and foundations, monolithic wall cladding, re-used aluminium windows and butyl rubber membrane to a small area of new flat roof. An existing concrete deck to the upper floor forms the roof to the remaining area, where a specifically engineered steel portal spans the opening created by the removal of the original wall.
