Determination 2008/24

Refusal to issue a code compliance certificate for a new house due to a dispute over compliance of jamb flashing at 213 Minden Road, RD6, Tauranga

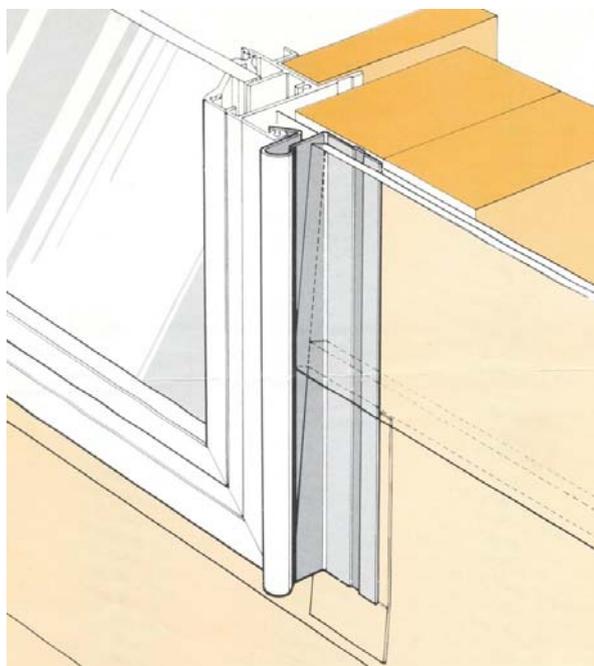
Figure 1: Installation detail showing the aluminium scribe (taken from the manufacturer's literature)

- 2.4 “Tru Fold” aluminium scribes (“the scribes”) are applied as part of the flashing system to the jambs of the external joinery units installed in the weatherboard-clad walls.

- the scribes are installed generally in accordance with the manufacturer's instructions
 - there is an adequate seal between the top of the scribe and the head flashing

- the weatherboards are sealed to the scribes
 - there is free drainage at the lower ends of the scribes and at the ends of lower weatherboards where they met the scribe (after the builder on site cleared small drainage channels)

- the plastic apron flashing installed between the scribes and the weatherboards is an appropriate and effective water deflection and drainage element. However the apron is sealed where it is "sandwiched" at its junction between the adjoining weatherboards

- as the scribe is "tucked in" behind the jamb, extends behind the weatherboards, and provides an effective drainage path, it is comparable to, and in some respects superior to the scribe profile shown in figure 42 of the Linea weatherboard manufacturer's recommendations.
