Determination 2008/70

Refusal to issue a code compliance certificate for a 10-year-old townhouse at 7A Emmett Street, Ponsonby, Auckland

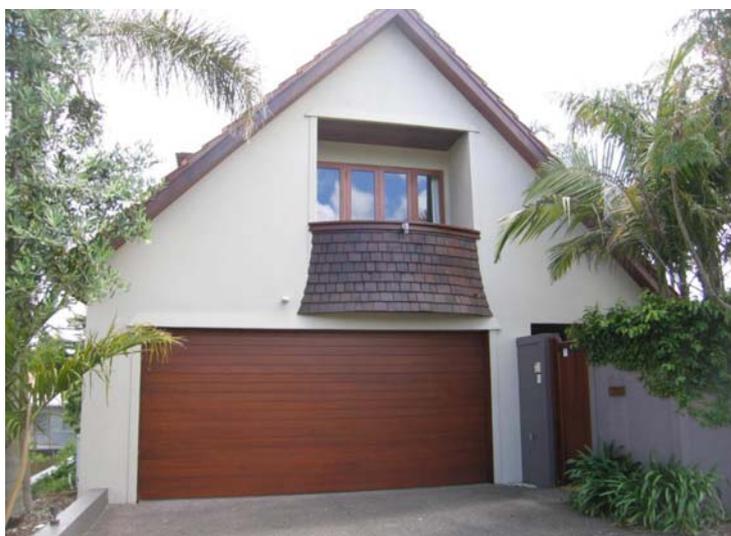
2.1 Unit 1 is a part two-storey, part three-storey townhouse with ground floor access at levels 1 and 2. It is situated on an excavated sloping site in a medium wind zone for the purposes of NZS 3604³. It is relatively simple in shape and form but with some complex features. Level 1 has a concrete slab and some concrete block walls. The remainder of the building is of timber framed construction built on timber-framed floors. The steeply pitched mansard roof has wall-to-roof junctions and minimal eaves and verge projections. There are six dormer windows and three skylights set into the roof. A small pitched roof is constructed over the lean-to projection on the west elevation and this roof has wall-to-roof junctions.
