## Determination 2009/77

### Determination regarding the refusal to issue a code compliance certificate for a 6-year-old block of 4 semi-detached townhouses at 3 to 9 Kora Avenue, Waitakere City

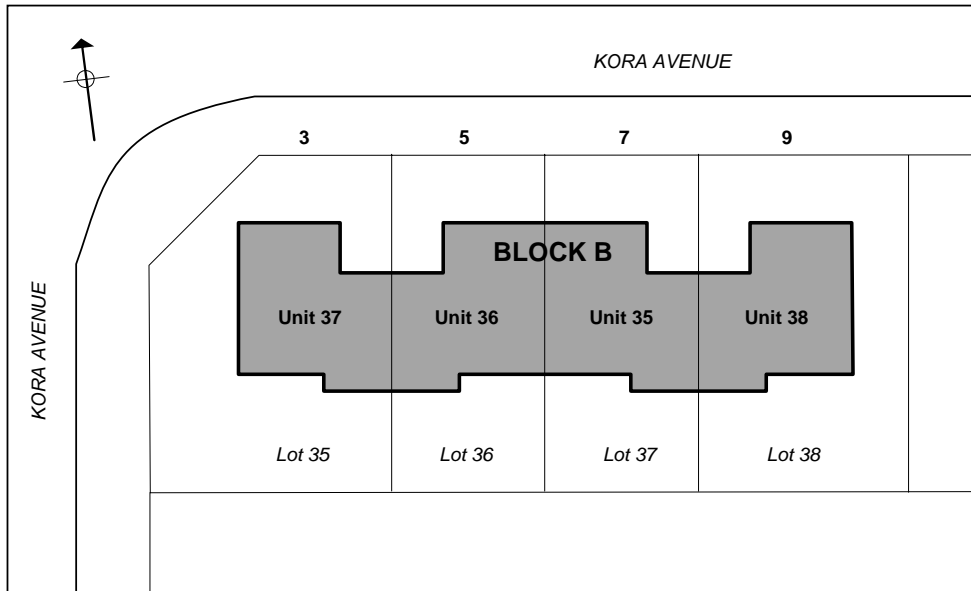
3.1 The following site plan shows Block B:
