## Determination 2009/2

# Refusal by an authority to issue a code compliance certificate for a house arising from the lack of a reinspection at 545 Maddisons Road, Templeton, Christchurch

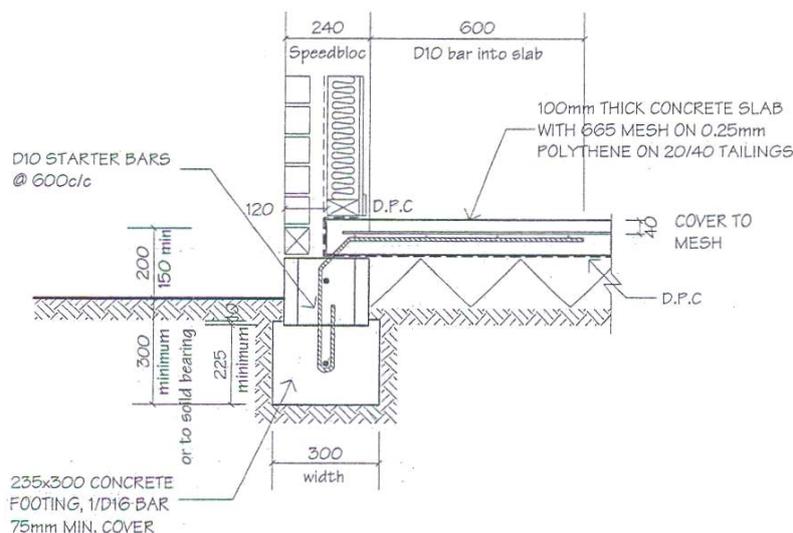
**Figure 1: The perimeter foundation detail as consented**

- 3.2 The perimeter foundation detail included in the approved consent documentation was as shown in Figure 1.
- 3.3 The authority carried out various inspections during construction, including a siting and foundations inspection on 17 December 2007, which recorded that re-inspection was required and noted:

- Work carried out not as per plans.  
Council consented plans were for speedbloc foundation.  
An authorized amendment is required.
- 3.4 The building company provided the authority with an amended foundation drawing (refer Figure 2) showing the footing as constructed. I note that the authority’s stamp on the drawing indicates this drawing was approved on 19 December 2007.

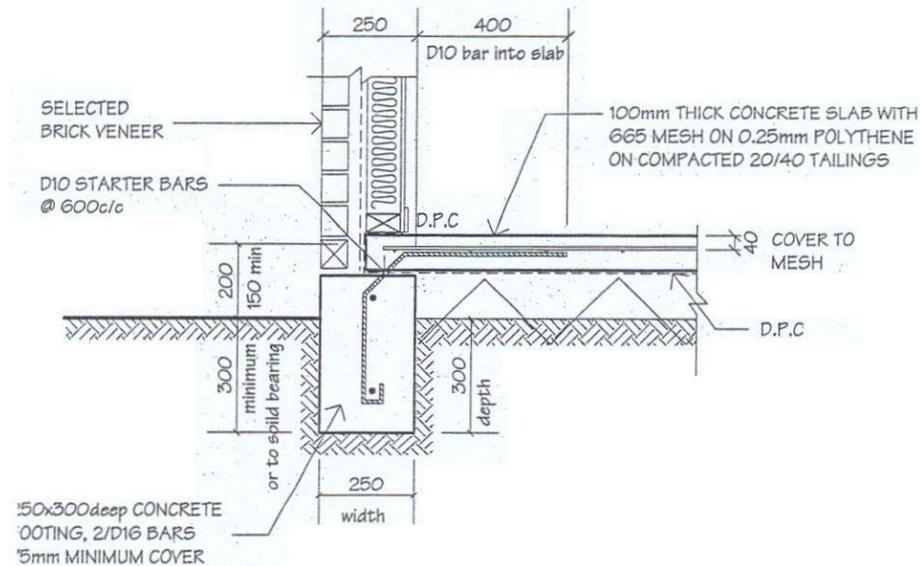
**Figure 2: The perimeter foundation detail as amended**

- 6.1 The authority has concerns that the foundations have not been adequately inspected, as the footings that were inspected varied from those shown in the original building consent. Although the amended foundation drawing was subsequently received and approved, the reinforcing was not reinspected against that drawing.

- 6.3 In regard to this situation, I make the following observations:
- Although the original consent drawings indicated a block footing “to be used as an alternative to standard footings in NZS 3604:1999”, standard footings were constructed.

- The building company has provided a producer statement confirming that the footings have D10 vertical starter bars with D16 horizontal bars in accordance with NZS 3604 and this has now been corroborated by the area exposed for inspection.

- The foundations are simple in design and the change is not major, with the reinforcing remaining similar and the footing depth unchanged.
- 6.4 A reinspection of the footings would have verified that the footings complied with the approved amended drawing.

- 6.5 I therefore consider there are sufficient grounds to conclude that the house foundations are likely to have been constructed in accordance with NZS 3604, and will therefore comply with Clause B1.
