Determination 2010/030

The issue of a code compliance certificate for two relocated buildings at 91 Whangapoua Road, Coromandel

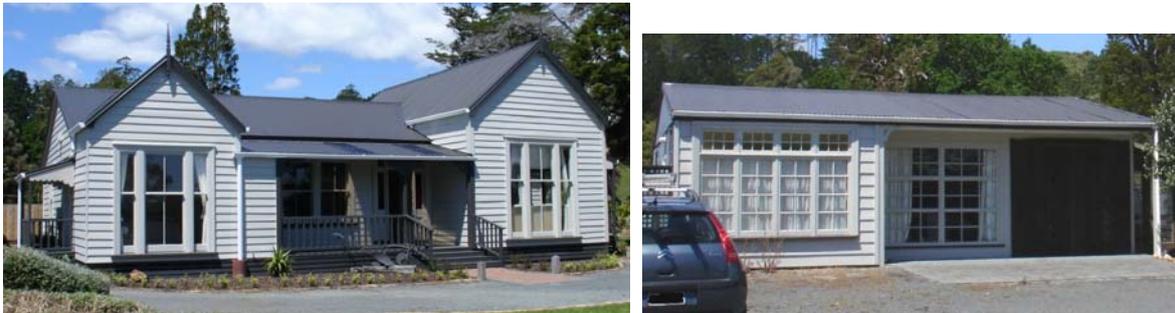
The house (left) and cottage (right)
