Determination 2010/059

Disposal of surface water collected behind a retaining wall at 336A Beach Road, Mairangi Bay, North Shore City

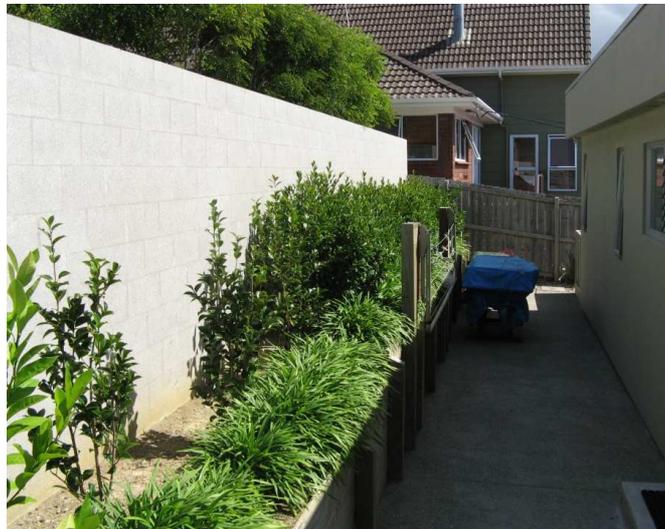
- 2.1 The wall is of concrete block construction. A plan of the wall is shown below as Figure 1. One length of the wall runs along the boundary between the owner’s property at 336A and the neighbours’ property at 336 Beach Road. Another length, at right angles to that, runs along the boundary between the owner’s property and the adjacent neighbour at 338 Beach Road. The wall retains up to approximately 1.6 m depth of soil, and parts of it also resist the surcharge from a driveway and parking area as shown on Figure 1. Along its length, the wall extends approximately 1 to 1.8 metres above the level of the retained soil to form a fence. Figure 1 does not show a low timber retaining wall on 336 Beach Road, see 2.8 below.

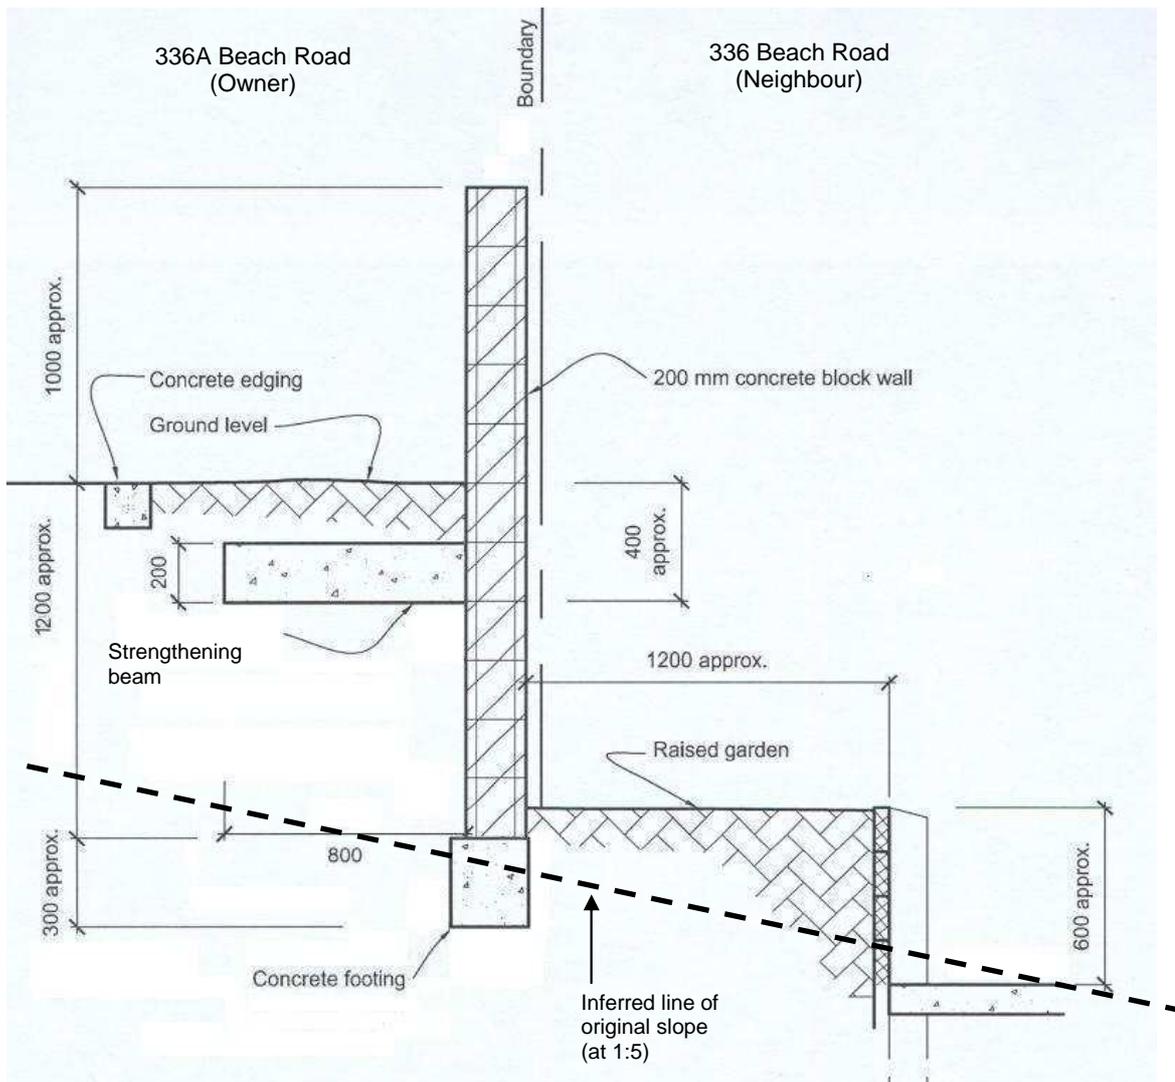
Figure 2: Section through the wall (draincoil not shown)
