Determination 2010/68

Determination regarding an application to amend a building consent for one unit in a 9-year-old block of twelve semi-detached townhouses at 139 to 161 Waterside Crescent, Gulf Harbour

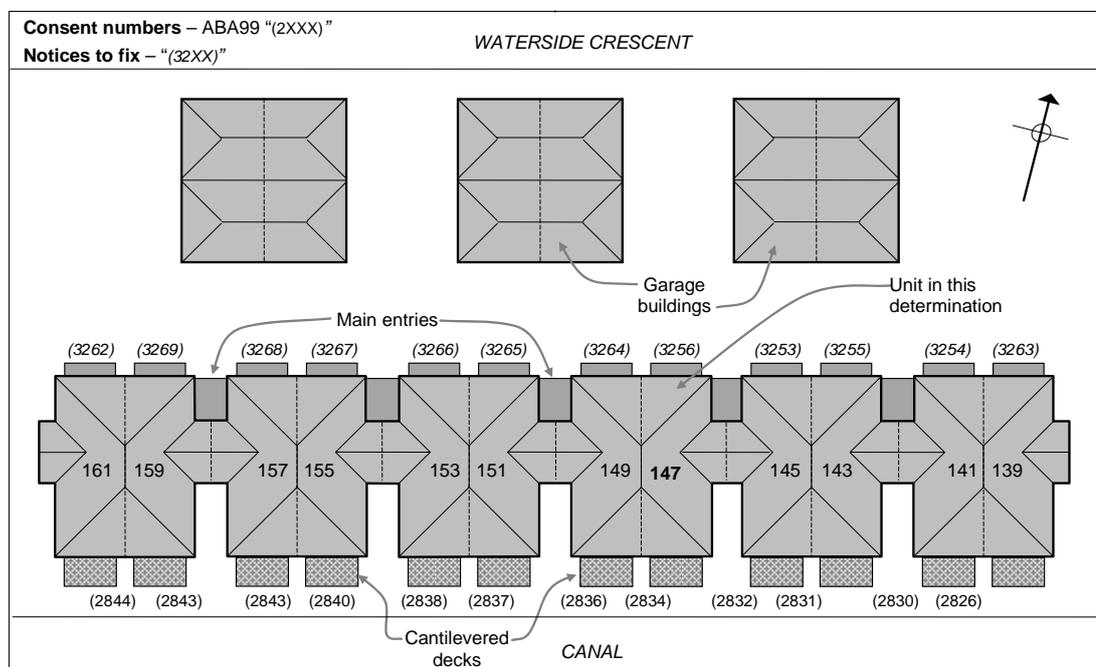
2.2 The following site plan shows Block B and the position of Unit 147 within the building. The sketch includes the building consent numbers and notice to fix numbers issued for each unit.
