## Determination 2010/77

# Refusal to issue a code compliance certificate for a 12-year-old addition and alterations to a house at 47 Regina Street, Westmere, Auckland

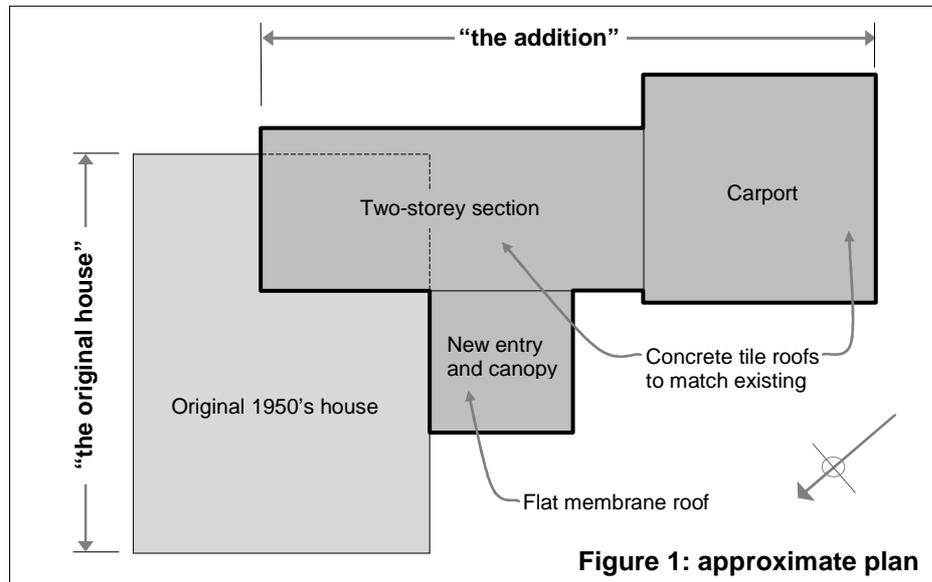
2.3 The addition is shown in Figure 1 below. The altered house includes:

- a new entry foyer and canopy
- a new kitchen, living area, bathroom, laundry and bedroom on the ground floor
- two bedrooms and a bathroom in the upper level
- a new double carport partly enclosed with framed walls.
