Determination 2010/90

Refusal to issue a code compliance certificate for 7-year-old additions and alterations to a house at 579 Old Tai Tapu Road, RD2, Christchurch

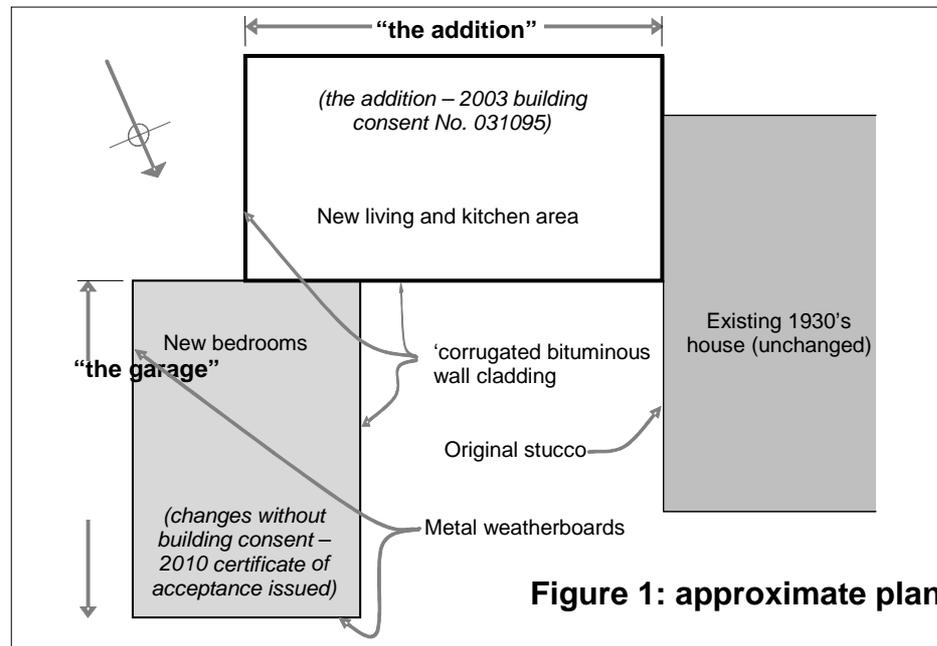
2.2 The building work considered in this determination is shown in Figure 1; and consists of an addition that links the original garage with the house to provide a new living and kitchen area.
