Determination 2010/092

Refusal to issue a code compliance certificate for an 11-year-old house at 12 Albert Road, Nelson due to concerns over steel frames and a retaining wall

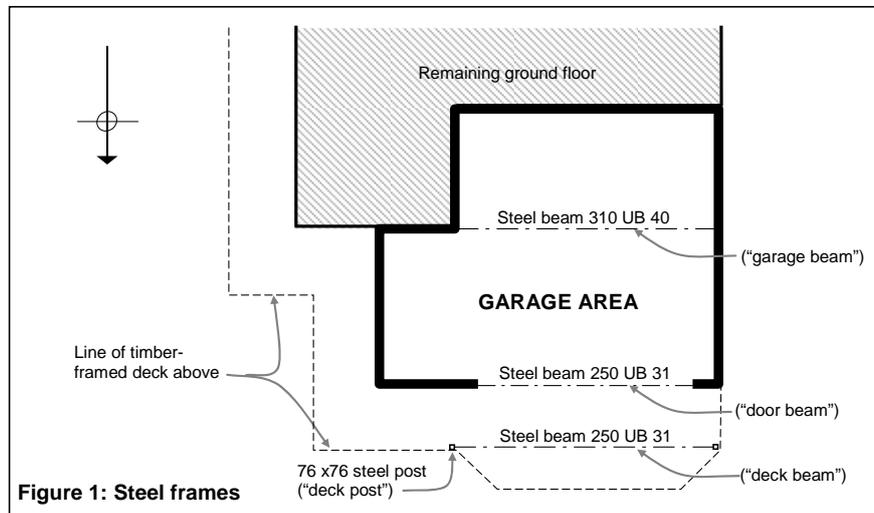
2.2.1 The steel frames consist of steel posts and beams installed to the garage and beneath the deck of the house, as shown in the sketch in Figure 1.

- 2.2.2 The garage and the deck beams span about 6m and the garage door beam spans about 5m. The steel posts to the garage and deck beams are 76mm x 76mm, while the posts to the garage door beam are 89mm x 89mm.

- stiffeners at each end of the beam as shown in the consent drawings
- fillet welds at the junctions of the posts with the beam
- at the west end, the post base was buried beneath asphalt
- at the east end the post was supported on a concrete pad that was 600mm x 400mm x 210mm deep, with a baseplate bolted into the concrete
- the painted steel had areas of light rust on the baseplate and the beam.

5.2.6 However, the expert was concerned about the concrete foundations to the deck posts, with one end hidden from view and the visible concrete pad at the other end only 210mm deep. The expert concluded that, while ‘the steel structure appears sound, the integrity of the concrete footing needs an opinion from an engineer’.

The deck support post foundations are inadequate and should be replaced with foundation pads of sufficient depth that they bear on the Port Hills gravels or firm clay. Excavations would need to be inspected and approved by a Chartered Professional Engineer.

- 6.1 Taking account of the expert's and the engineer's reports, I conclude that remedial work is necessary for the following areas:
- the foundations of the deck support posts, as described by the engineer in paragraph 5.5.2
 - the light corrosion apparent to some areas of the steelwork.
- 6.2 The authority's inspection records, the expert's report and the engineer's statements allow me to conclude that the remaining areas of the steel frames are likely to be adequate, despite the lack of engineering oversight commented on by the authority (refer paragraph 3.5). I am therefore able to conclude that satisfactory rectification of the areas outlined in paragraph 6.1 will result in the frames being brought into compliance with Clauses B1 and B2 (insofar as it applies to B1) of the Building Code.
