Determination 2010/093

Refusal to issue a code compliance certificate for a small addition to a house at 48 Russleigh Drive, Hamilton

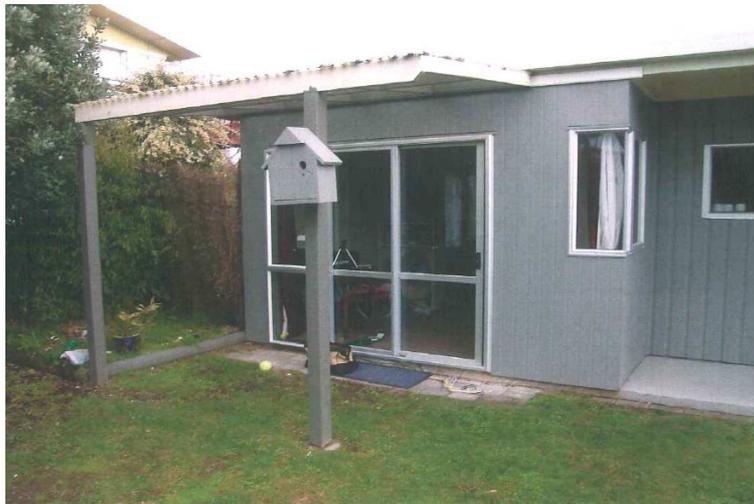
- 2.1 The building work consists of a 1.2 x 3.0 metre addition to a bedroom with a small veranda. The addition was built over an existing concrete terrace and under the existing roof overhang.
- 2.2 The single storied addition is timber framed and clad in profiled fibre-cement sheets nail fixed to the framing with an acrylic paint finish, and has face fixed aluminium joinery.
- 2.3 There is a new lean-to verandah which provides some protection to the eastern exterior wall and its associated aluminium-framed sliding glass door. There are no eaves to the south wall or the north end of the east wall.
