Determination 2010/116

The issuing of a code compliance certificate for a house at 12 Fairhaven Walk, Wade Heads, Whangaparaoa

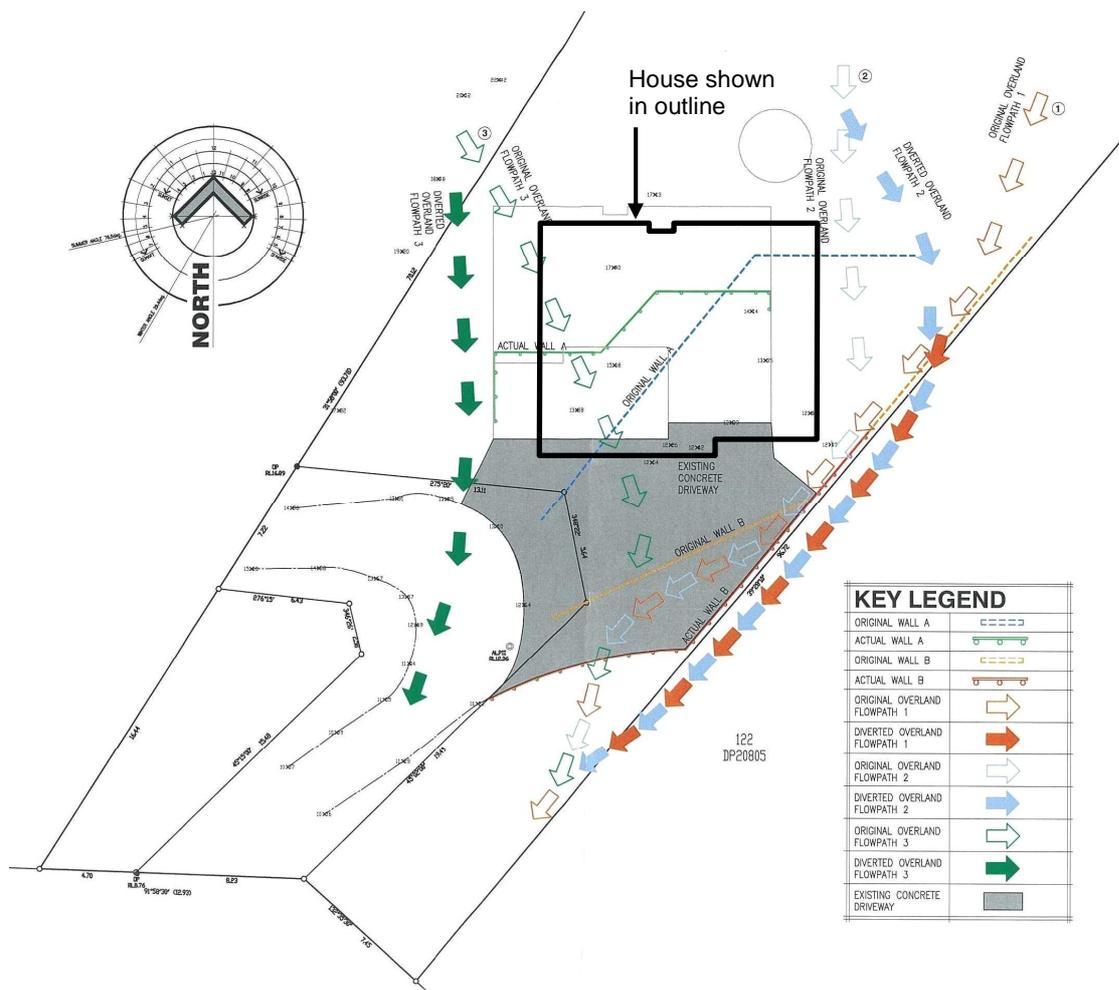
Figure 1: Site plan showing the house and the overland flow paths

- 2.3 The No 10 property shares a common boundary on the east side of the applicant's property, and an overland water flow path (watercourse) runs along this boundary. Two other flow paths also pass through the applicant's site and all three of the flow paths have been diverted significantly from their original positions by work performed under the resource consent and by the building work carried out under the building consent.
- 2.4 Two retaining walls have been erected on the site as follows:
- Retaining wall A, constructed to protect the cut excavation beneath the house.
 - Retaining wall B, situated to the south east of the house and along the common boundary with No 10.
