Determination 2010/124

Refusal to issue a code compliance certificate for a 10-year-old house that has been re-clad at 415 Seaforth Road, Bowentown

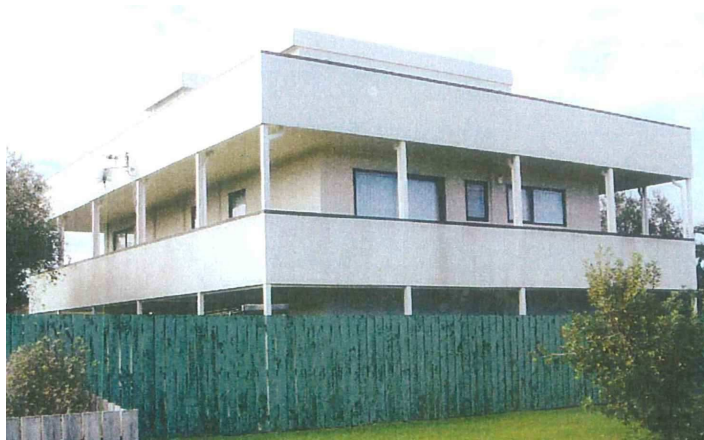
2.1 The building is a three storey residential house. The house is sited on a flat site with sea views to the east. It is situated in a very high-wind and a sea spray zone, for the purposes of NZS 3604⁴. It is constructed with timber framing with some steel post and beam elements, founded on concrete foundations and a concrete floor.

2.3 The building has two perimeter decks. The upper deck comprises a liquid-applied membrane in plywood overlaid with tiles that is, in part, located over habitable rooms. The lower deck is of open timber. Both decks have solid balustrades of timber framing clad with fibre-cement sheet.
