Determination 2011/008

Refusal to issue a code compliance certificate for a 9-year-old house with macrocarpa posts and beams at 16 Oak Tree Lane, Rolleston

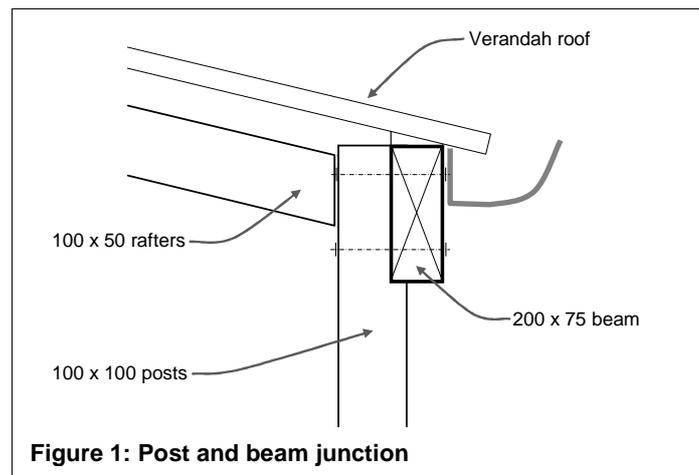
2.3.3 The posts are rebated and bolted to the inside of the verandah support beams, with rafters fixed to posts and beams as shown in the following sketch:
