Determination 2011/085

Regarding the issue of a notice to fix in respect to a channel drain to a house at 2/35A Wheturangi Road, Greenlane, Auckland

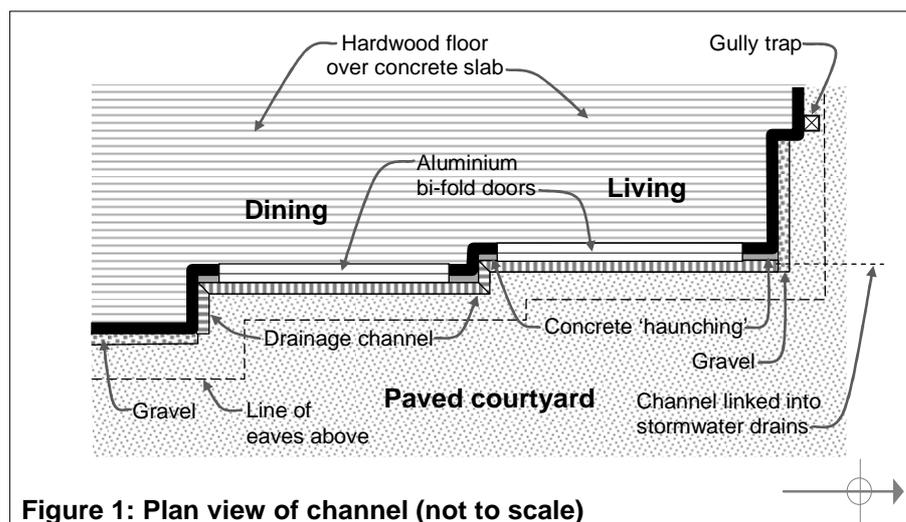
- 2.1 The subject drainage channel is to part of the rear elevation of a two-storey house situated on a level building platform in a low to medium wind zone for the purposes of NZS 3604⁴.
- 2.2 The construction of the house is generally conventional light timber frame, with a concrete slab and foundations, timber weatherboards over a cavity, aluminium joinery with timber facings and sills, and profiled metal hipped roofing with eaves of more than 500mm overall.
- 2.3 Lean-to roofs extend over ground floor walls, including above the drainage channel, which extends along part of the east (rear) elevation as shown in the plan view sketch in Figure 1.

5.2.1 The expert noted that the 130mm wide and 120mm deep drain is 7.4m long and drains to the northeast corner of the house, where it connects to the stormwater system. The paved area adjacent to the channel drain is about 20m², with a maximum slope of 1:100 away from the drain. The expert described the channel junction; and I have incorporated his comments within the sketches in Figure 1 and Figure 2 (see paragraphs 2.3 and 2.4).

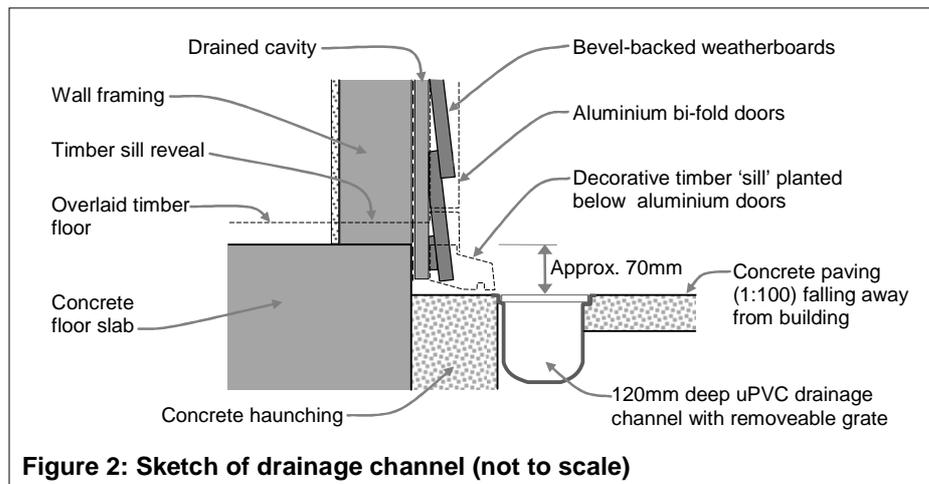
- 2.4 Based on the limited information available, an indicative sketch of the wall to paving junction at the channel drain is provided in Figure 2:

5.2.2 The expert noted that water run-off from the large doors flows over the planted timber sill onto the edge of the channel drain, the bottom of which is about 190mm below the bottom plate level. However, the top of the concrete haunching to the foundations is exposed at small sections of weatherboards adjacent to the doors.

- concrete haunching adjacent to weatherboards provides an exposed ledge about 70mm below the bottom plate level, which prevents aggregated clearances from being measured to the bottom of the channel
- there is only about 20mm clearance below the bottom painted edge of the weatherboards to the concrete ledge, which makes repainting 'next to impossible' and the edge subject to deterioration unless treated to H3.2
- there is only about 2 to 3mm clearance below the bottom edge of the timber sill below the slicing doors to the concrete haunching, which makes the timber effectively in contact with paving and subject to deterioration unless treated to H4.

6.3.3 A method of providing adequate clearance to the bottom of the weatherboards and door way sills to the bottom of the subject walls is a matter for the applicant and his designer to propose. The presence of the concrete haunching prevents adequate clearances for draining and drying to the bottom of the cladding and joinery. I suggest that this may require removal of the haunching and modifying channel drain to extend it back to the main slab. An experienced designer will be able to investigate the existing construction and consider how this could be affected.
