## Determination 2011/095

### Regarding the code-compliance of a channel drain around the foundation of a house and garage at 533 Waitoki Road, Wainui, Auckland

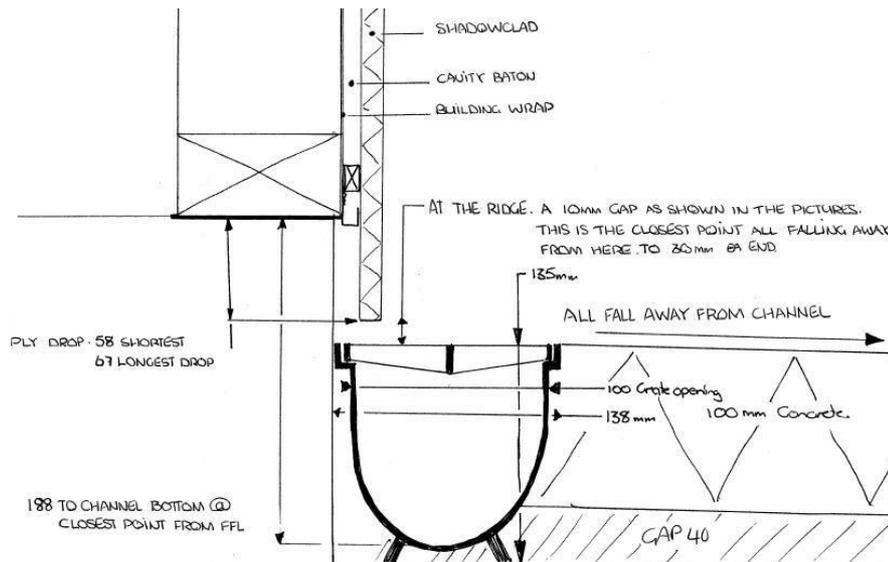
**Figure 1: Section of the channel drain-as built (as provided by the applicants)**

- 2.6 A proprietary black plastic channel drain has been installed along the rear elevations of the house, and around three sides of the garage. The channel drain is made from black polypropylene and is 138mm wide by 135mm deep with a removable grate. The grate has an open area of approximately 60%. Figure 1 shows the channel drain as installed.

- 5.3 The expert further noted that the top of the concrete paving is generally around 70-100mm below the floor slab and noted that the plywood cladding extends 60-70mm below the cavity closure. The bottom of the channel drain was 120-140mm below the bottom edge of the plywood cladding.

- 5.4 The expert noted that the plywood cladding terminates ‘very close to the [grate of the channel drain] in places’ which raised the possibility of water hitting and bouncing up off the grill and hitting the bottom edge of the plywood cladding. The expert observed, in at least one instance, that the bottom edge of the plywood was not protected by a coating system. The expert was of the opinion that if the edge was not protected ‘water may soak into the plywood in sufficient quantities to cause premature deterioration of the cladding’, and that the effect of water ingress on the bottom plate should also be considered.

6.4.6 The clearance from the concrete floor to the concrete paving adjacent to the cladding is between 70-100mm. The clearance from the concrete floor to the bottom of the channel drain at its highest point is 180mm. The clearance from the bottom edge of the cladding to the bottom of the channel drain directly below the cladding is 120-140mm. The paved surfaces fall away from the building.

6.4.7 The grate to the channel drain has an open area of 60%, and the grating itself has rounded top surfaces. I do not consider the amount of water likely to hit the grate and splash up is sufficient to adversely affect the adjacent building elements.

- 6.5.1 I consider that the channel drain is installed in a manner that does not compromise the building's compliance with Clause E2.3.2. However, I accept the expert's opinion that the clearance from the cladding to the channel drain is minimal at some locations and that these lesser clearances should be increased by trimming back the cladding, corner battens, and similar; and sealing the unpainted bottom edges of these elements: I note the 35mm minimum clearance shown in Figure 18 of E2/AS1 may be used for guidance in this respect. I consider this work is necessary to ensure the building's ongoing compliance with Clause B2 Durability insofar as it relates to Clause E2 External moisture.

- 6.5.2 I acknowledge that the channel drain will require regular inspection and maintenance so that it remains clear of debris, but the performance of the drain is readily observable. I suggest that the end of the channel drain that discharges by the timber deck be extended, so that the discharge point is extended beyond the outer edge of the deck.
