## Determination 2011/107

### The issue of a notice to fix in respect of 10-year-old additions and alterations at 29 Halesowen Ave, Sandringham, Auckland.

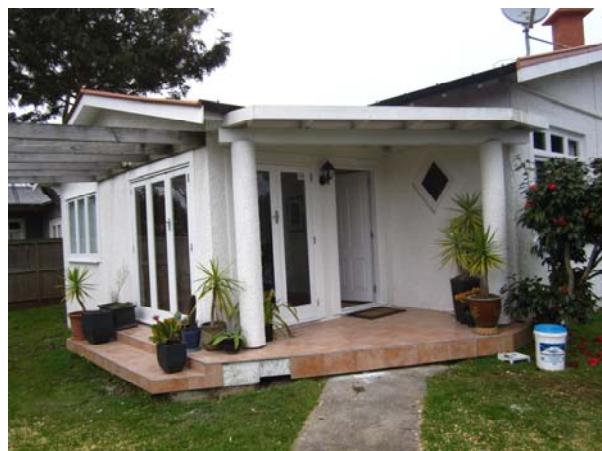
- 2.1 The building is a single storey house located in a low wind zone in terms of NZS3604<sup>5</sup>. The original house was constructed in the 1930s with solid concrete walls and featured a heavily textured plaster finish.

- 2.2 The addition that is the subject of this determination comprises a two bedroom addition and entry/conservatory that is sited on the north elevation of the existing house. The addition was founded on the existing concrete patio, and timber bearers and joists have been attached to the patio.

- 2.3 The addition is conventional light weight timber framing with a 20° pitched hand painted corrugated iron roof with a flat roof over the entry that is supported by two timber posts. The roof-to-wall junctions formed by the flat roof are largely sheltered under eaves of approximately 300mm. The cladding is plaster over fibre-cement board, with a texture coating applied to match the appearance of the original house. Joinery is wooden.
