## Determination 2012/021

### Regarding the refusal of a code compliance certificate and the issue of a notice to fix for alterations to a house at 26 Benson Road, Remuera, Auckland

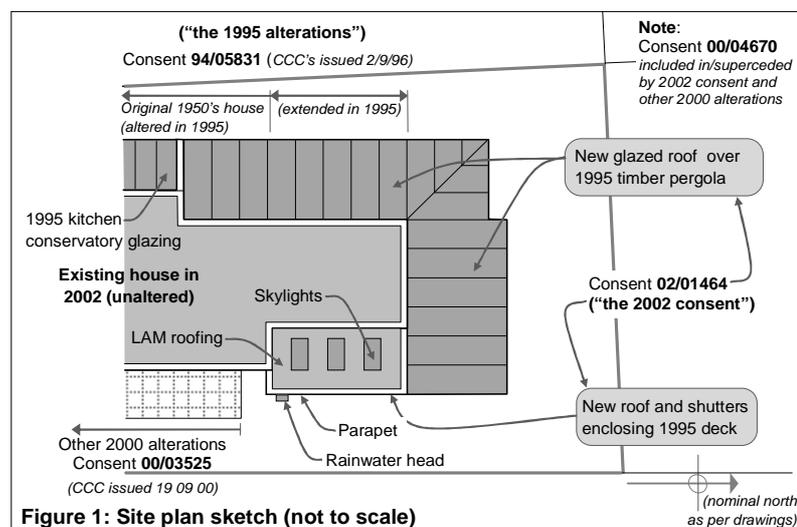
2.3.1 The subject alterations were carried out under the 2002 consent and incorporated the pergola glazing originally covered by AC/00/04670. The 2002 alterations are shown in the sketch in Figure 1:

- installation of the glazed roof over the existing ground floor pergola, including:
  - replacement of existing north pergola beam with new flitch beam
  - a glazed roof fixed onto the 1995 pergola rafters with aluminium clamp bars and gaskets supporting laminated glass panes
- additions to the 1995 deck to provide a semi-enclosed area, including:
  - new roof framing and skylights, with liquid-applied membrane over plywood substrate
  - new parapet framing, with plaster cladding to match existing
  - existing columns and balustrade tops packed out to accommodate new rain screen type timber shutters, with plaster and borders to match existing.

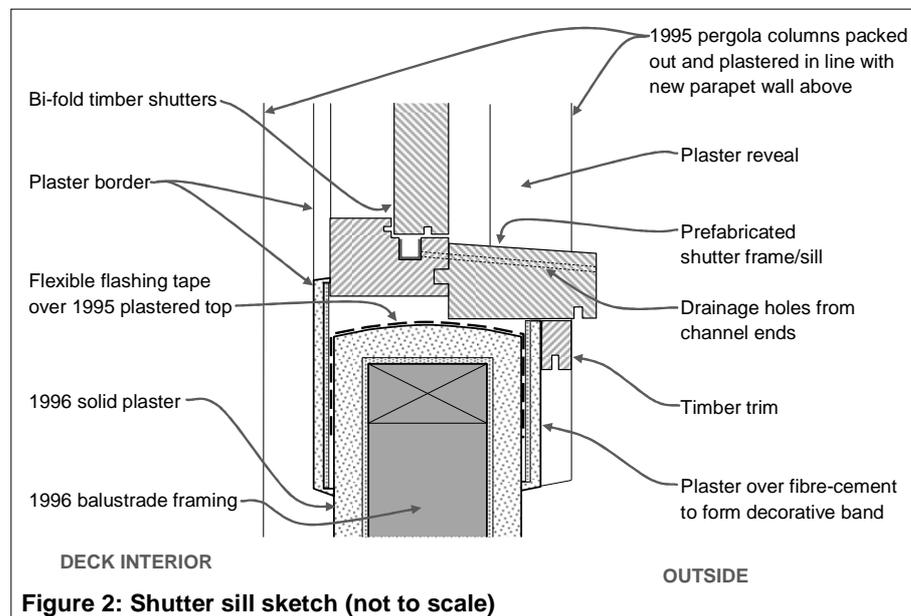
2.5.2 The installation of the timber shutter sill is shown in the sketch in Figure 2:

6.4.1 The expert discussed the timber shutter installation with the builder and Figure 2 shows the likely sill details, based on the builder’s recollections and on-site measurements (see paragraph 2.5.2). The shutters were installed as prefabricated units within prepared openings, with plaster applied at reveals and decorative bands.

6.4.2 The expert noted that the weatherproofing of the 1995 plastered balustrade framing is dependent on the flashing tape applied to the balustrades top. Although scupper defects are likely to have caused the highest moisture level of 28%, the expert considered that further investigation is needed to establish cause(s) of the elevated moisture levels under the shutter sills, as they may relate to other defects. (refer to paragraph 6.8.1)
