## Determination 2012/072

### Regarding the authority's exercise of its powers in refusing to issue a code compliance certificate for a 9-year-old house at 12 Parkwood Place, Hamilton

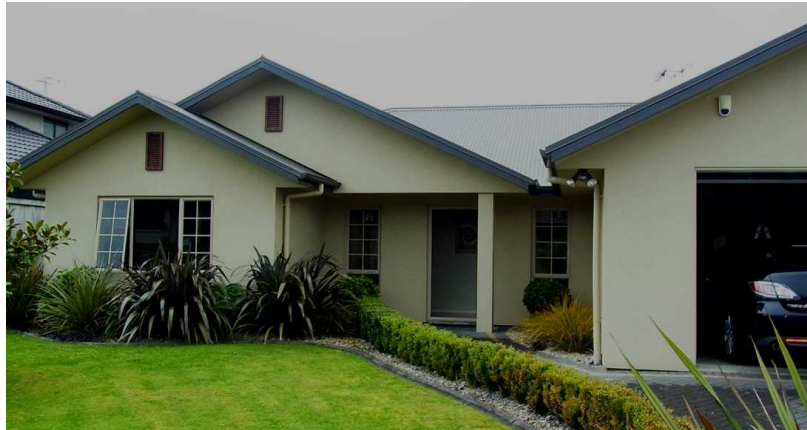
2.2 The house is of timber-frame construction built on concrete ground floor slabs and foundations. The steeply pitched roofs are covered with corrugated pre-finished metal roofing and generally have 600mm eaves and verge projections. The exterior walls are lined with 60mm polystyrene EIFS<sup>5</sup> sheets directly fixed to the framing and finished with a textured plaster overlay.

- 5.2 The report described the house in general terms and gave some of the background to the dispute. The expert stated that the construction quality was above average and that ‘very good’ maintenance had been carried out. Generally, the cladding was well fixed and aligned and there was no evidence that the plaster finish had cracked or contained any other imperfections. The roof and exterior joinery flashings were ‘tidy and effective’.
