Determination 2012/003

Regarding the refusal to issue a certificate of acceptance for alterations to a house with monolithic cladding at 3/8 Pupuke Road, Hillcrest, Auckland

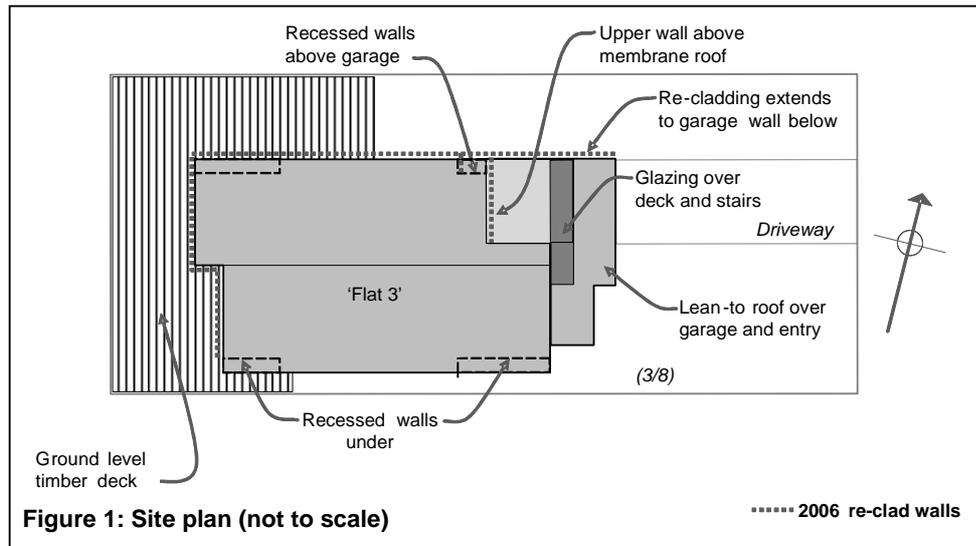
2.3.1 It appears that moisture problems in some walls lead to some cladding being replaced in 2006. The applicant's builder believing that the work was 'like for like' and therefore would not require a building consent. Wall cladding was removed from the north and west walls and the upper east wall of the living room as shown in Figure 1.
