Determination 2013/042

Regarding compliance with the Building Code and with the building consent of roof structure components installed in a house at 16 Highland Drive, Richmond

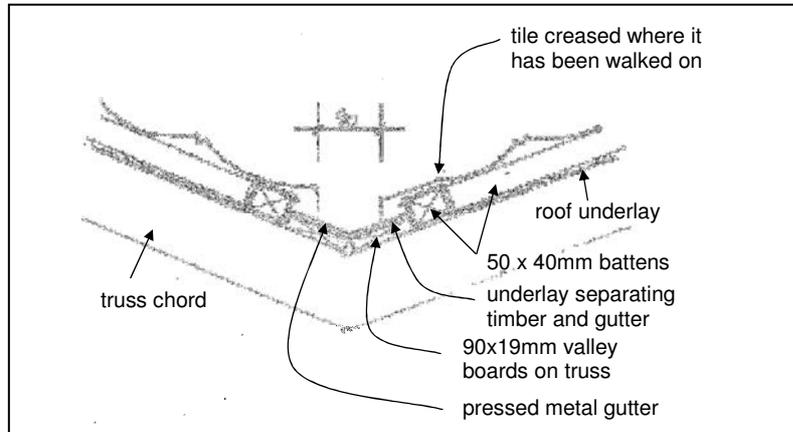
- 2.6 The expert described the valley boards as finished 90x19mm timber decking run on top of the truss chords, and provided an as built detail (see Figure 1).

Figure 1: The valley gutters as built

- the valley is not wide enough to walk in.
- 5.4.7 The expert noted that the valley boards on top of the truss effectively reduce the amount of upstand that can be formed on the valley gutter. The manufacturer's manual and the Acceptable Solution show the upstand at 35mm and 20mm respectively. The tile batten is 40mm thick and the valley board is 19mm thick, which establishes the effective valley gutter upstand height as 21mm.

- 5.4.8 The expert noted that there was no return on the top edge of the valley gutter upstand and a continuous batten has been fixed each side of the gutter. Damage was apparent to the tiles where the batten adjacent to the gutter has been walked on.

- 5.4.9 The expert observed no evidence of moisture ingress, and considered that the reduced size of the valley board would not compromise the function of the board. The expert noted that the valley boards are not connected to the continuous batten adjacent to the gutter; the continuous battens span up to 1.8m.

6.3.5 The valley gutters have a reduced cross-sectional area and therefore a lower capacity than that described in E2/AS1. The valley gutters collect water from relatively small areas of roof; the expert observed no water ingress adjacent the gutters and the gutters have been subject to several severe rainfall events since their completion. I consider the valley gutters are adequate in terms of the collection of water from the roof.

6.3.8 While the valley boards are not wide enough to walk on, the 50x40mm continuous batten adjacent the boards will be walked on: the continuous batten spans up to 1.8m. An internal review by the Ministry has found that the continuous batten will resist wind uplift, but it is not adequate in terms of the live load from a person on the roof. The framing immediately adjacent the gutter does not comply with Clause B1 and additional support under the continuous batten is required.
