Determination 2013/060

Regarding the refusal to issue a code compliance certificate for a 10-year-old house with a concrete tile roof at 209 Jowers Road, West Melton

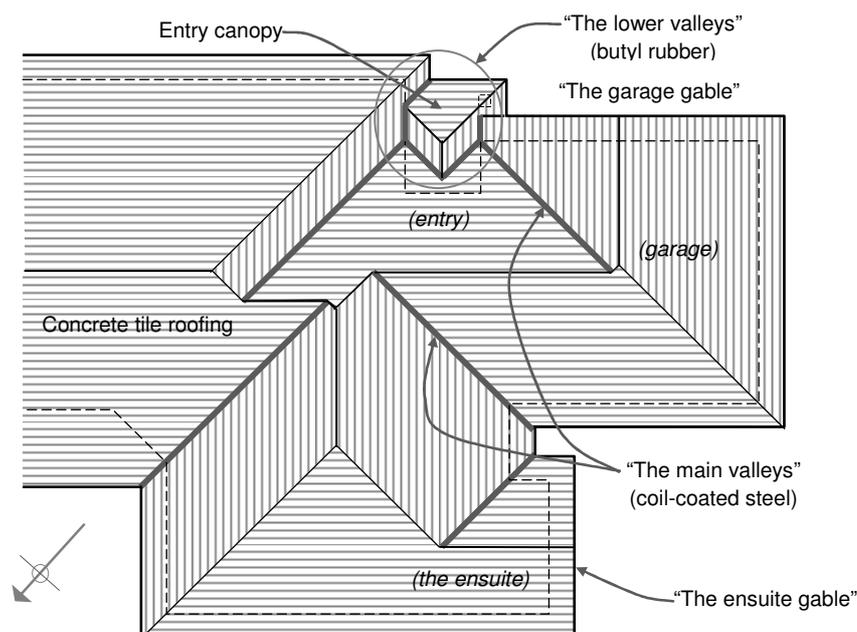
Figure 1: Roof plan (not to scale)

- 2.3 The 25° pitch hipped and gabled roof has eaves and verges of more than 600mm overall. The two gable ends include steel 'secret gutters' at the verges; concealed below metal barge flashings and intended to direct water into external gutters. The main valleys to the roof are coil-coated steel, which fall towards butyl rubber lower valleys above the entry as shown in Figure 1.

- there are five junctions where valleys meet ridges (refer Figure 1); and mortar has been carried onto the gutter lining as bird proofing in lieu of mesh, which is reported by roofers to be a common practice
- cement plaster and coil-coated steel are noted in Tables 21 and 22 of E2/AS1 as compatible in both contact and water flow
- the metal valley gutters have been in place for 10 years with no apparent problems and are required to achieve a 15 year minimum durability
- although not noted by the authority, mortar also carries onto membrane valley linings and constricts the valley width.
