## Determination 2014/001

# The refusal to issue a code compliance certificate for a 10-year-old house with metal and monolithic claddings at 3 Baxter Way, Karori, Wellington

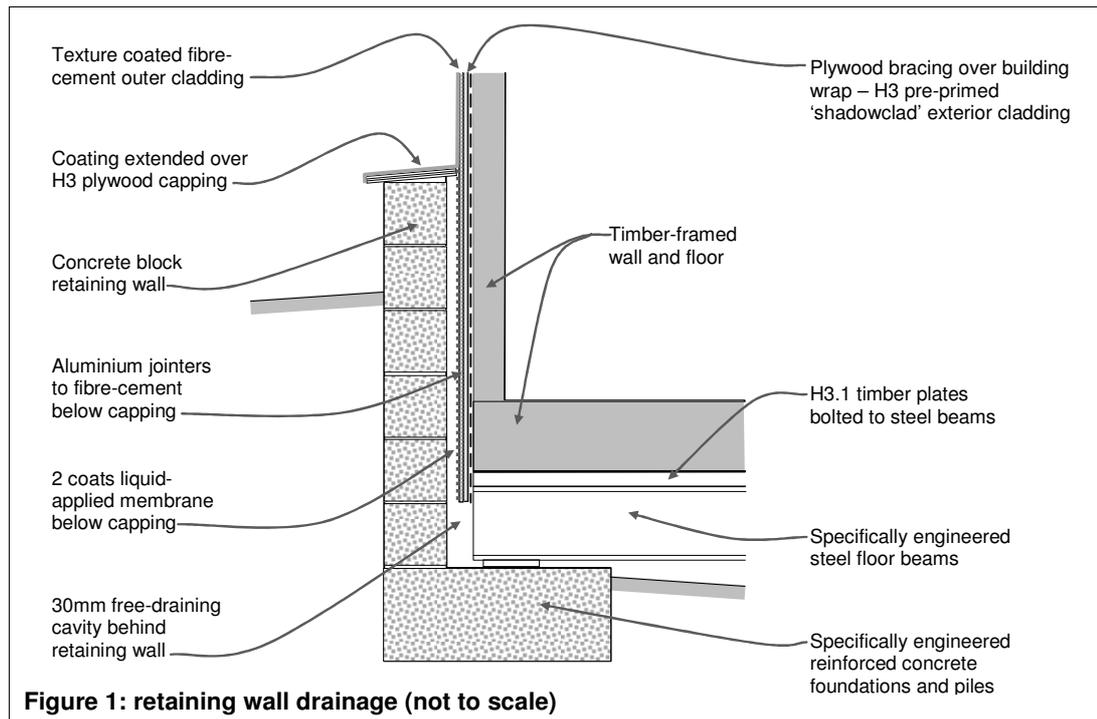
- 2.4.2 The upper walls are clad in horizontal corrugated steel, which is fixed through the plywood sheathing and the building wrap directly to the framing timbers with proprietary folded metal flashings at corners, windows, and other junctions.
- 2.4.3 The lower walls are clad in a form of monolithic cladding, which is a proprietary flush-finished fibre-cement cladding system consisting of 7.5mm thick fibre-cement sheets fixed through the plywood sheathing and the building wrap directly to the framing and finished with an applied textured coating system.
- 2.4.4 The northwest corner to the lower level includes a low concrete block retaining wall, isolated from the exterior wall by more than 30mm, which provides a drainage gap to allow moisture to escape into the ventilated subfloor area as indicated in Figure 1:
