Determination 2015/003

Compliance of a retaining wall between two properties at 34A and 36B Ballin Street, Ellerslie, Auckland

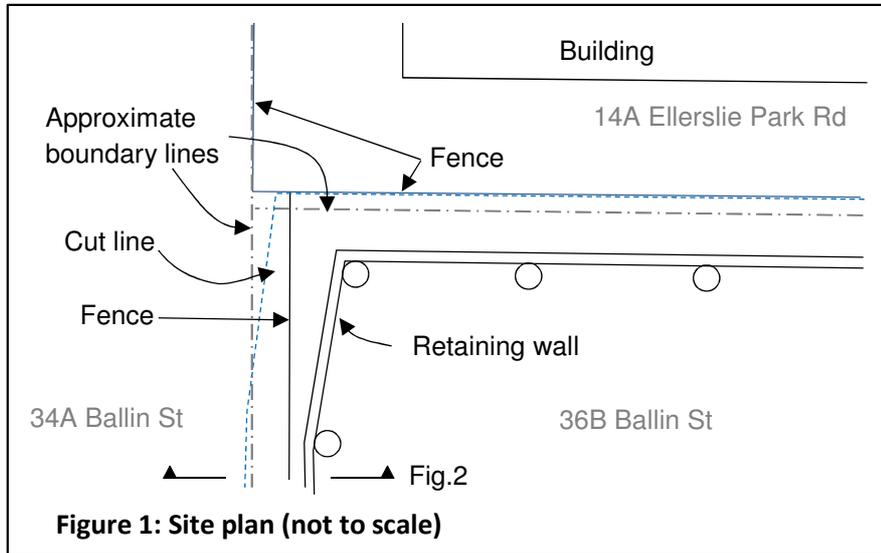
- 2.1 The building work consists of a timber retaining wall constructed on or near the boundary between 36B Ballin Street (“36B”) and the adjacent properties at 34A Ballin Street (“34A”) and 14A Ellerslie Park Road (“14A”) – refer Figure 1 below.

- 2.2 The site at 36B was excavated to the approximate cut line shown in Figure 1 above. The retaining wall is constructed approximately 350mm inside the boundary of 36B to an estimated height of 1100mm, with the ground behind the retaining wall backfilled to the height of the retaining wall.
- 2.3 The fence between 36B and 34A has been constructed approximately 100mm out from the retaining wall.
- 2.4 The difference in height between the ground level in 34A and the top of the retaining wall is up to 500mm and was left as an open cut face – refer figure 2 below “as-built”.

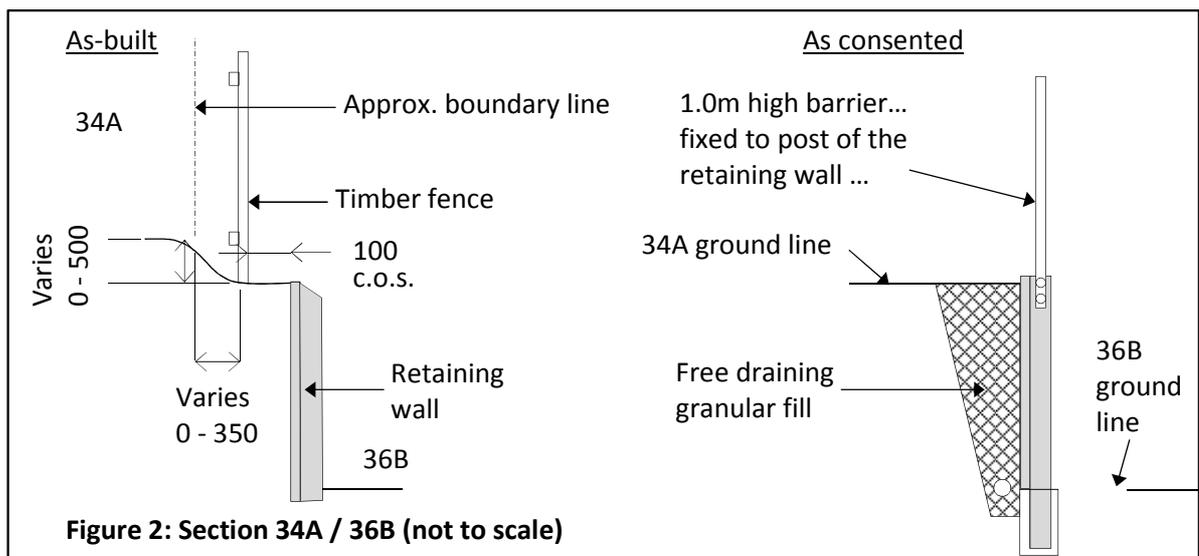
- The consent drawings indicate the top of the retaining wall (RL 46.65m) as being 1150mm above the proposed floor level (RL 45.50m).
- Allowing 200mm from the proposed floor level to the finished ground level, and assuming level ground between the dwelling and the retaining wall, this would indicate the retained height was more likely to be 1.35m not 1.1m.
- The retaining wall design and drawing covers retained heights up to 2.0m; the expert had no concerns regarding the design and calculations.
- The drawing depicts a barrier attached to the top of the wall and indicates essentially level ground behind the wall (refer Figure 2); boundaries are not indicated on the retaining wall design drawings.

5.3 During the site visit the expert located a boundary peg and noted that the excavation had been taken right up to the boundary but appeared not to have been cut in a straight line. The fence was constructed approximately 100mm from the retaining wall, and the difference in level between the actual ground level in 34A and the top of the retaining wall was up to 500mm and left as an open cut face. The cut face would be concealed by the fence when looking from 36B.

- 6.5 The expert has stated that if open cut face is left un-retained it can be expected to continue to slump and that slumping would progress into the property at 34A. I accept the expert's opinion in this matter. In this respect I consider that the unsupported face cannot be said to have 'a low probability of becoming unstable' throughout its lifetime and accordingly I consider the excavation did not comply with

6.9 The expert has also raised the concern that the retaining wall as constructed may not allow for the correct earth pressures. The expert’s report confirms that the retaining wall has the capacity to withstand a 12kPa surcharge and was intended to allow for a future driveway, but presently some 9.0kPa of this has been taken up by the raised height of the ground level behind the wall: the 12kPa surcharge should not be exceeded. Should a driveway be constructed behind the wall, the ground level behind the wall would need to be lowered to reduce the surcharge on the wall.
