Determination 2015/029

Regarding the issue of a notice to fix and the refusal to issue a code compliance certificate for 11-year-old alterations to a 1970s solid timber house at 86 Koneburn Road, Waimanu

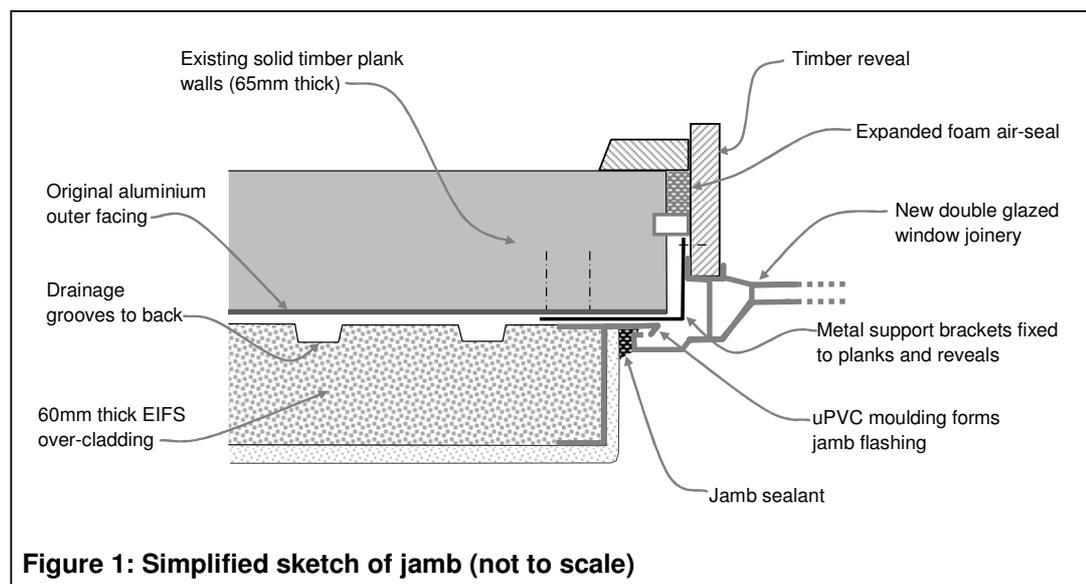
2.4.2 In the case of the addition, the EIFS system is fixed directly to the framing over the building wrap. In the case of the original house, EIFS is installed over the solid wall planks, with the new aluminium double glazed windows installed as shown in Figure 1.

- In comparison with the original windows, the new windows (see Figure 1) include head, jamb and sill flashings within the EIFS system and can be expected to achieve at least the same level of protection to the junctions.
