Determination 2015/033

Regarding the compliance of repairs proposed for the tile roof of a 7-year-old house at 6 Shadbolt Lane, Rolleston

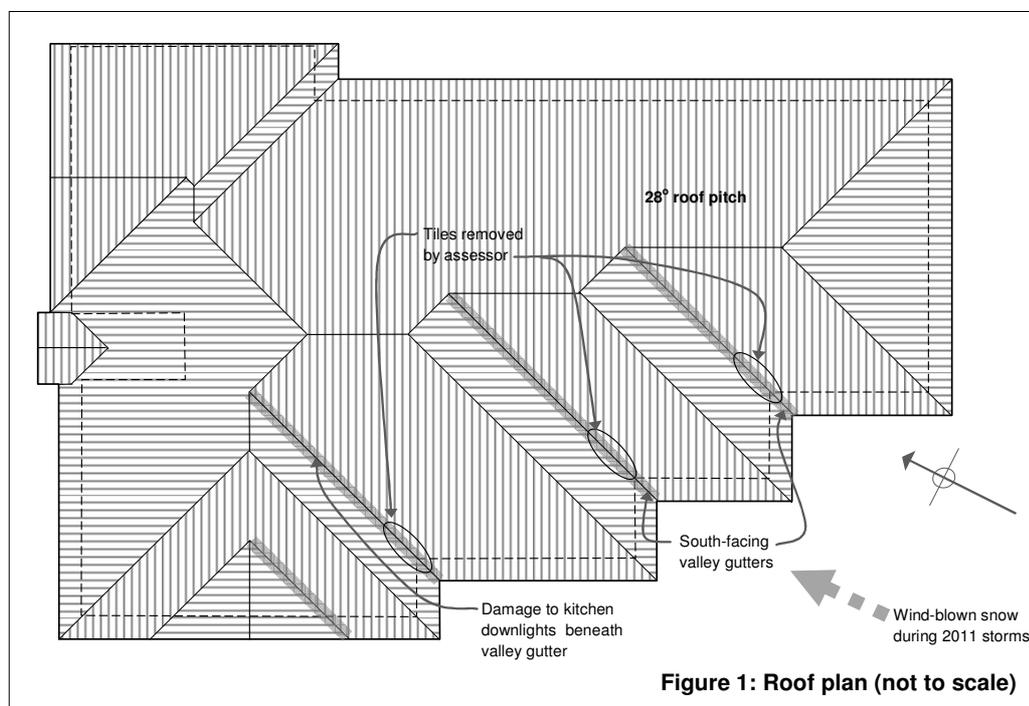
- 2.1 The subject roof repairs are on a detached house situated on a level semi-rural rural site in a high wind zone as described in NZS 3604⁴. Construction is generally conventional light timber frame, with a concrete slab and foundations, masonry veneer cladding, aluminium windows and concrete tile roofing.
- 2.2 The 28° pitched hipped roof includes gables above the northwest garage and entry canopy, and a small projecting gable to the southwest living area. The roof generally has eaves and verge overhangs, except above the northeast wall of the garage and the southwest projecting gable above the living area. The roof plan is fairly complex, with many valley gutters as shown in Figure 1.

3.3.1 In order to investigate the underlying construction, the assessor inspected the valley gutters and removed roof tiles at three locations (see Figure 1 at paragraph 2.2); contrasting the as-built junctions with comparable details in E2/AS1 and NZS 4206.

- The lines of cut tiles at valleys are inconsistent and some locations have only 85mm effective cover, compared to 100mm minimum shown in Figure 27.
- Significant gaps were apparent between the top of the valley gutter upturn and the underside of the cut valley tiles, some large enough to allow a hand to be inserted into the roof space.

3.5 In regard to 'primary deficiencies' identified in the valley gutters, the assessor therefore limited the remedial work 'to repair current and likely future damage' to the removal of tiles at the sides of valley gutters and the installation of seals at the tile overlaps to the gutters.
