Determination 2015/034

Regarding the authority's exercise of its powers of decision in refusing to issue a code compliance certificate for a 1-year-old house with profiled metal roof cladding at 8 The Drive, Twizel

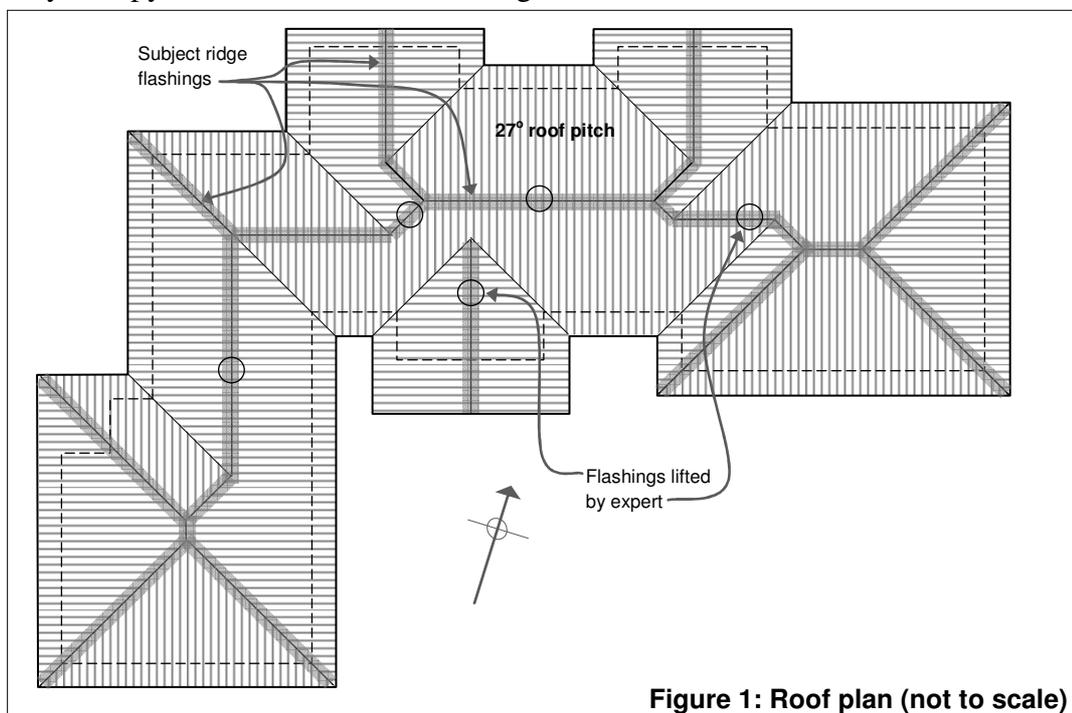
Figure 1: Roof plan (not to scale)

- 2.2.1 The 27° pitched hipped roof includes two projecting gables to the north and a gabled entry canopy to the south as shown in Figure 1.

5.3.1 In order to investigate the underlying construction, the expert raised the ridge flashing at five locations (see Figure 1), and noted that in each location:

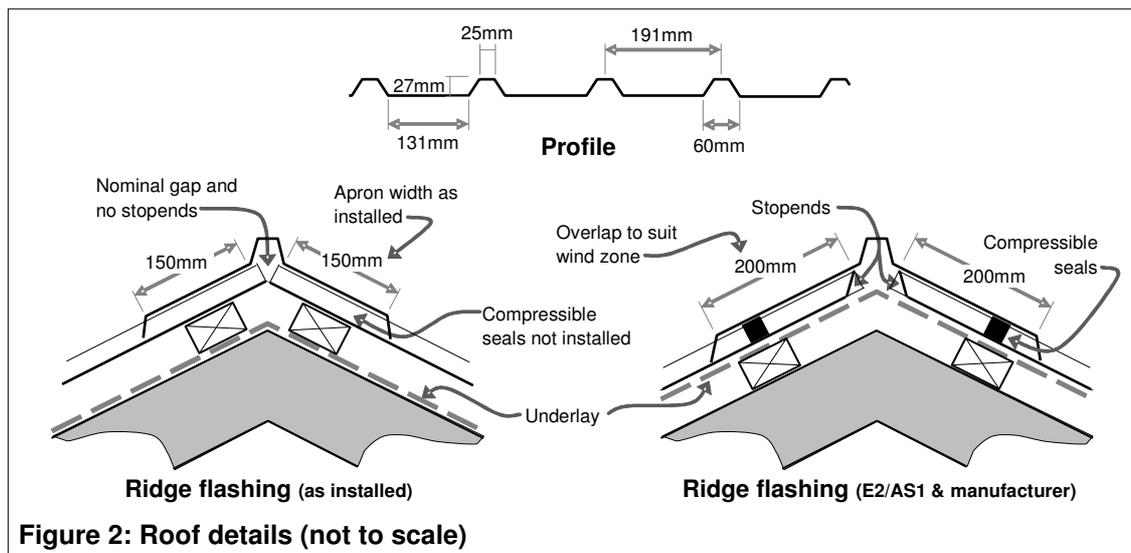
2.3.2 The manufacturer of the installed trapezoidal roofing provides details for common junctions, edges and intersections, including for ridge flashings as shown in Figure 2.

2.3.3 The manufacturer's ridge detail shows:

- the flashing overlapping the roofing by a dimension to accord with Table 7 of E2/AS1⁵, which calls 200mm minimum overlaps in very high and extra high wind zones
- the ridge flashing turned down over the roofing profile
- compressible seals installed between the flashing and the roofing
- stop ends to the top of roof sheets
- roofing underlay wrapped over the ridge.

2.3.4 The expert investigated underlying construction at the roof ridges (see paragraph 5.3.1). As shown in Figure 2, the installed ridges include:

- installed flashings with aprons of about 150mm
- the tops of roofing sheets extended to almost meet at the apex
- no stop ends to the top of roof sheets
- no compressible seals installed between the flashing and the roofing
- roofing underlay wrapped over the ridge.

5.2.2 The expert discussed the situation with the owner who understood that the reduced width of the ridge flashing had resulted from the positioning of the top purlins (see Figure 2). The owner had been assured that the roofer 'had taken the roofing sheets right up to the apex line with only a nominal gap and that stop end turn-ups had been formed along with the building paper being carried over the ridge line'.

- no stop ends are installed to the top of the sheets
- no compressible seals are installed under the flashing
- the sheets carry up to the apex, with only a nominal gap, therefore increasing the effective cover of the ridge flashing

- there was no visual evidence of moisture tracks under the flashing, with a layer of fine dust apparent on the roofing surface.

According to E2/AS1 and manufacturer (see Figure 2)	The installed ridge flashing system (see Figure 2)
Recommended ridge flashing details for the trapezoidal roof profile are appropriate for slopes down to 3°	The 27° pitch installed roof is well above the minimum, improving the shedding of water and the effectiveness of overlaps.
The aprons to ridge flashings should provide 200mm minimum overlap in very high wind zones	The installed ridge flashings are intended for lower wind zones, where a minimum overlap of 150mm is required.

According to E2/AS1 and manufacturer (see Figure 2)	The installed ridge flashing system (see Figure 2)
The manufacturer's ridge flashings allow for about 50mm gap between the top roof sheets at the apex	The roof sheets are installed with a nominal gap at the apex, so increasing the effective cover to about 175mm.
Compressible seals restrict any water that is driven under the ridge flashing	No compressible seals have been installed.
Sheet ends are turned up to restrict any water that may reach the tops of roofing from penetrating at the apex.	No stop ends have been installed to the tops of roofing sheets.
The roofing underlay is wrapped over the apex to allow any water that penetrates past the flashing to drain to the outside.	The underlay is wrapped over the apex to overlap beyond the ridge line

6.2.2 Taking into account the expert's report and the above observations, I consider that the dimensions of the ridge flashings installed to this house are likely to perform at least as well as a 200mm overlap used on this particular roof profile installed on a minimum roof pitch of 3°.

6.2.3 However the expert's investigations also identified significant omissions and I therefore consider the remedial work is necessary to the roof ridges in respect of:

- the lack of stop ends to the tops of the roofing sheets
- the lack of compressible seals between the ridge flashing and the roofing.

- stop ends were formed to provide an upstand height of 10mm minimum
- compressible seals were installed in accordance with manufacturer's details.

6.3.2 Because the identified omissions occur in discrete areas, I am able to conclude that satisfactory rectification of the items outlined in paragraph 6.2.3, either singularly or in combination, will result in the ridge flashings being brought into compliance with Clauses E2 and B2 of the Building Code.
