Determination 2015/050

Regarding the refusal to issue a code compliance certificate for a 19-year-old house with a 14-year-old addition at 19A John Rymer Place, Kohimarama, Auckland

Summary

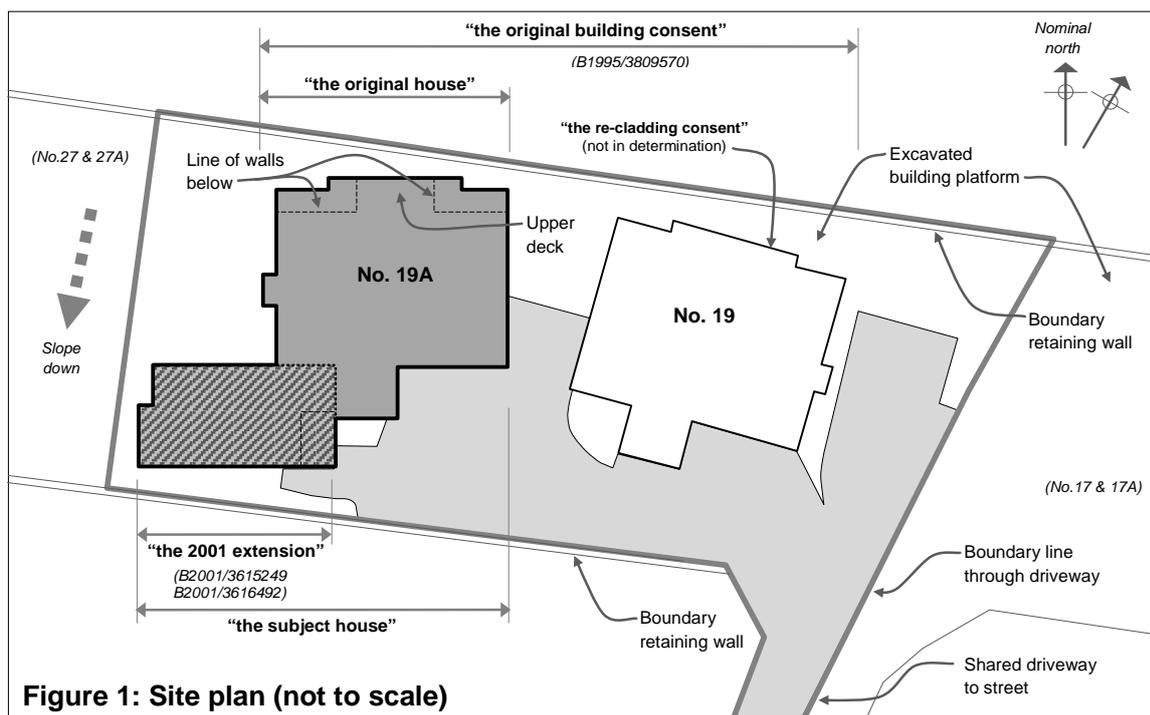
- 2.1.1 The house is part of a larger development on an excavated south-sloping site in a high wind⁴ zone as described in NZS 3604⁵. Retaining walls created building platforms extending across the slope to include neighbouring two-unit properties.
- 2.1.2 The house which is the subject of this determination (No.19A) was originally constructed under the same original building consent as the adjacent house (No.19). Both houses had very similar designs, construction and materials and share the same leasehold property, with driveway access to the street also shared with the neighbouring 2-unit property (17 and 17A) as shown in Figure 1.
