Determination 2015/069

Determination regarding the compliance of retrofitted metal sill flashings to timber windows and doors installed in a 132-year-old house at 17 Hepburn Street, Freemans Bay, Auckland

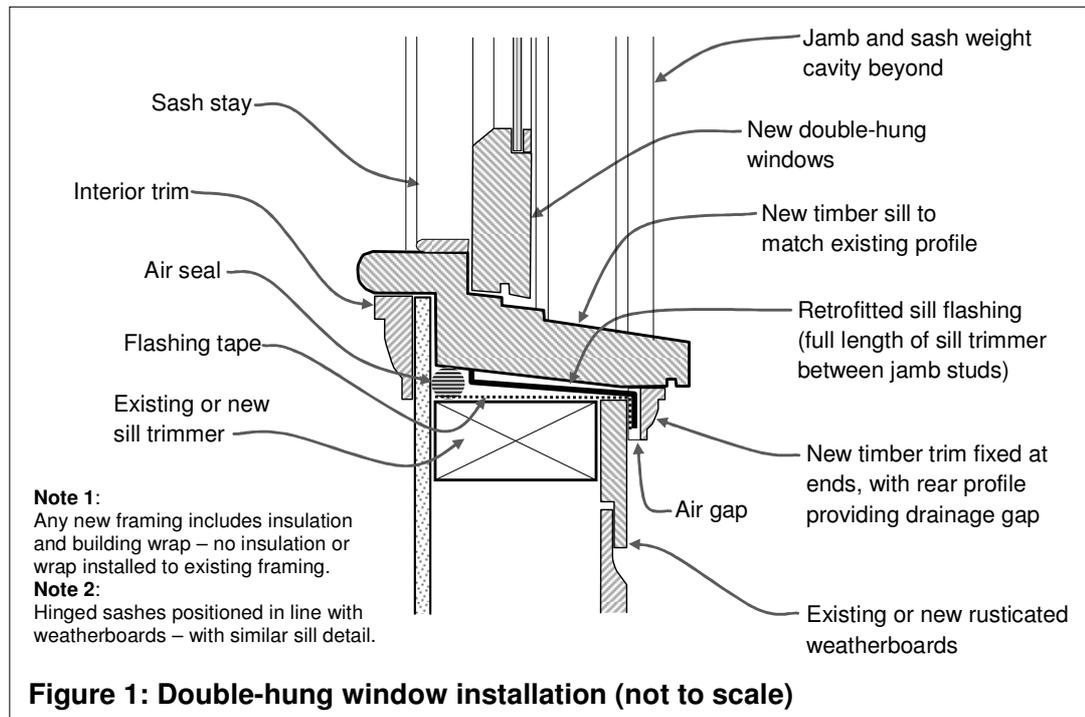
2.3.2 The installation of consented windows is shown in Figure 1.

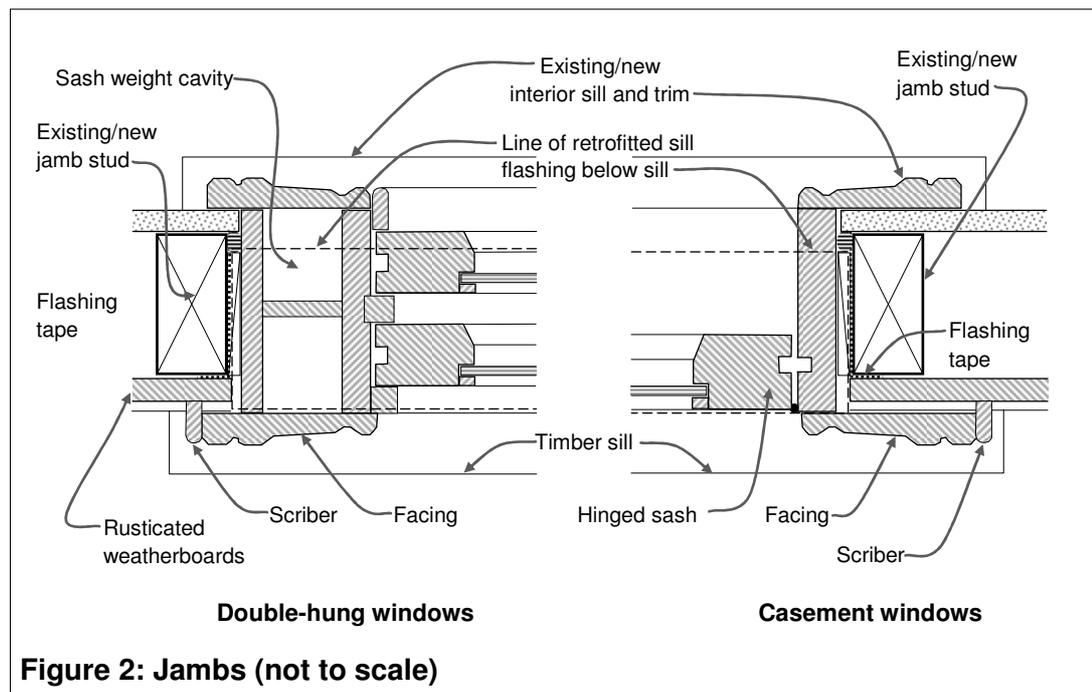
- 2.3.3 The retrofitted metal sill flashings extend the full length of the framed openings; with the ends terminating against the flexible flashing tape where it turns up against the jamb trimmers. The jambs are shown in Figure 2.
- 2.3.4 The replacement windows were installed within original window openings. A total of ten double-hung windows were apparently replaced, and sashes were replaced in a further seven windows with the existing window frames left in place.
