Determination 2016/024

The refusal to issue a code compliance certificate for a 21-year-old house with corrugated steel wall cladding at 16 Rotoiti Street, Dunedin

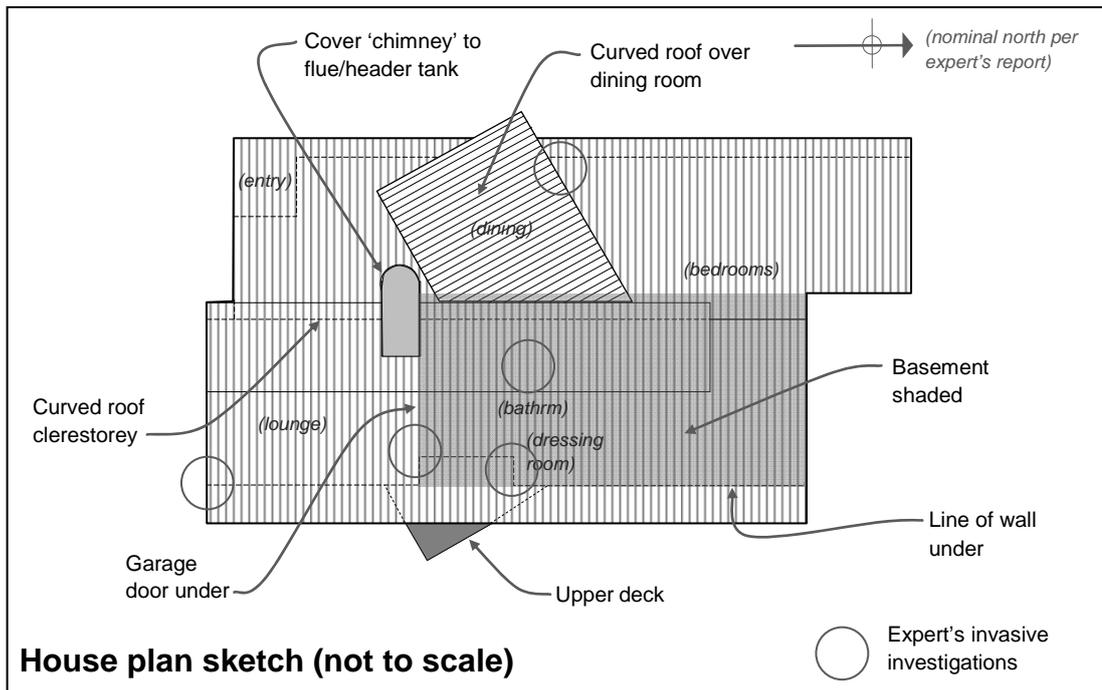
Figure 2: The house

- 2.2 The house accommodates living areas, three bedrooms and an office in the upper level, with a fourth bedroom and a garage in the partial basement. A small upper deck, with a membrane floor and open timber balustrades, extends from recessed sliding doors in the east wall of the lounge, with part of the deck situated above the basement garage below and the remainder cantilevered beyond the basement wall as shown in Figure 2 (over page).

- 2.4 The roof is a mix of gables and monopitch roofs as shown in Figure 2, with eaves generally greater than 600mm overall, no verge overhangs and a raised curved section above the ridge to provide west-facing clerestory windows. A separate curved section to the west is raised above the living room and oriented at an angle to the main roof. The latter roof extends out as an angled projection beyond the west wall line, with full height glazing curved at the top in line with the roof.
