Determination 2016/057

Regarding the performance of a concrete floor slab and foundation with respect to moisture transmission to a house at 5 Main Road, Redcliffs, Christchurch

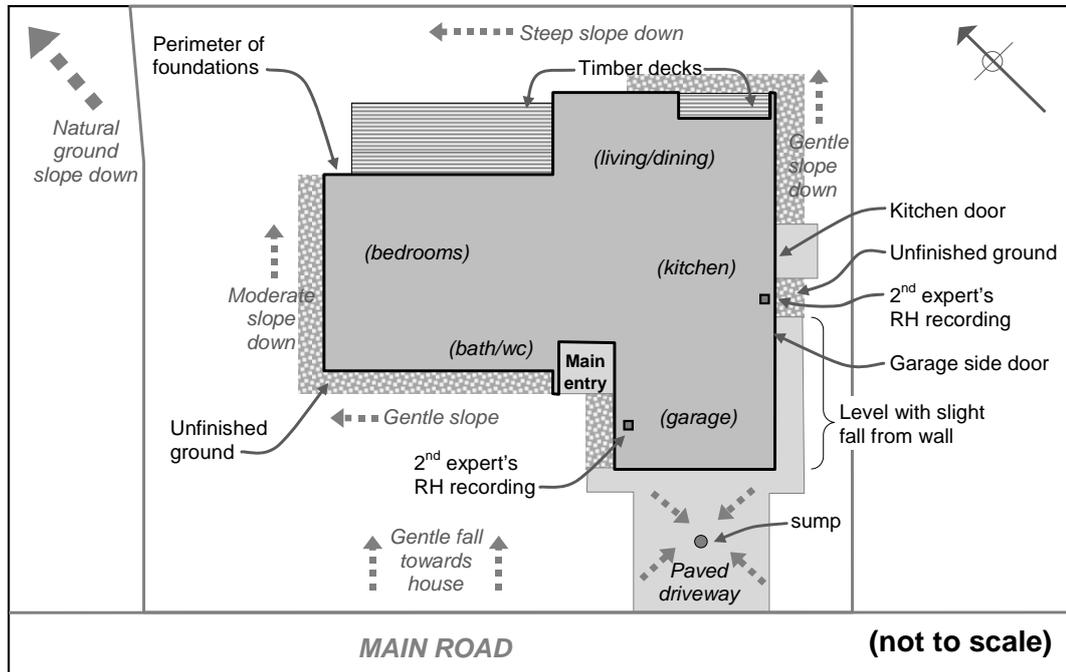
Figure 1: Site plan

- 2.5 The site is north-sloping, with the garage and main entry facing southwest toward the street. At the time of the experts' inspections, landscaping had not been completed and ground contours were approximately as shown in Figure 1:

- 5.2.1 The expert checked the site levels against a datum at the west corner of the garage (see Figure 1) and noted that:
- ground between the southwest elevation and the street lacks topsoil and currently slopes gently down toward the house
 - ground levels against northwest wall fall more steeply towards north corner
 - most ground to the southeast elevation is paved, with limited clearances to the finished floor level ("FFL") and a slight slope away from the wall
 - ground levels to northeast elevation fall fairly steeply from about 1m below the FFL at the east corner towards the north corner
 - the driveway slopes gently towards a sump in the middle of the drive.
- 5.2.2 The expert also noted that downpipe locations accord with the consent site plan and testing surface water drainage with a hose confirmed satisfactory operation.

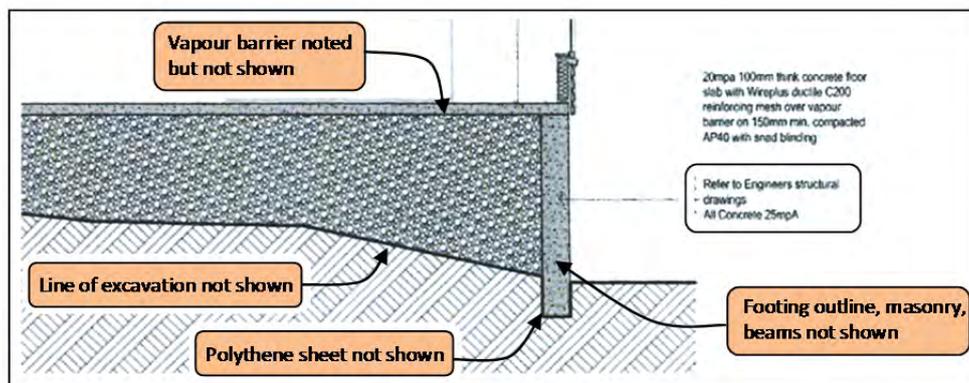
Figure 2: Foundation detail in architectural drawings with my notes added

- 3.1.1 The authority issued building consent no. BCN/2013/2518 for construction of the house on 16 October 2013.
- 3.1.2 The consent drawings prepared by the designer called for a DPM immediately beneath the reinforced concrete floor slab and referred to the structural drawings for the foundations as shown in Figure 2:

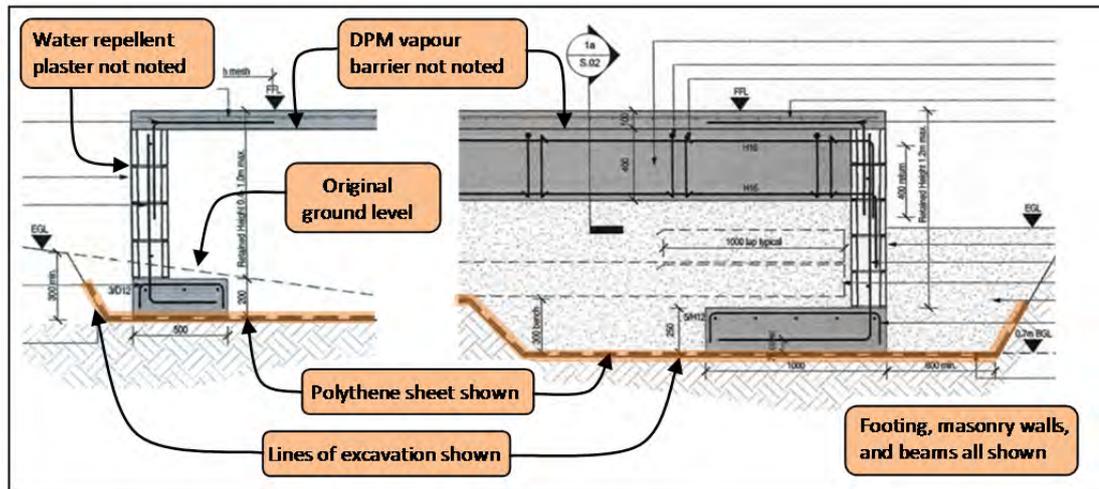
Figure 3: Foundation detail in engineering drawings with my notes added

- 3.1.3 According to the builder, the designer's drawings were 'extremely vague' and clearly referred to the engineering drawings: as well as providing details, the engineering drawings 'called for a double layer of polythene to extend past the building line' (as shown in Figure 3).

- 3.2.2 It appears the builder followed the engineering drawings, and foundation boxing and floor plan footprint were lined with two layers of polythene with lapped and taped joints at junctions and the polythene extended beyond the building line.
