Determination 2017/005

Regarding the code compliance of remediation work to a 15-year-old house at 238 Plummers Point Road, Tauranga

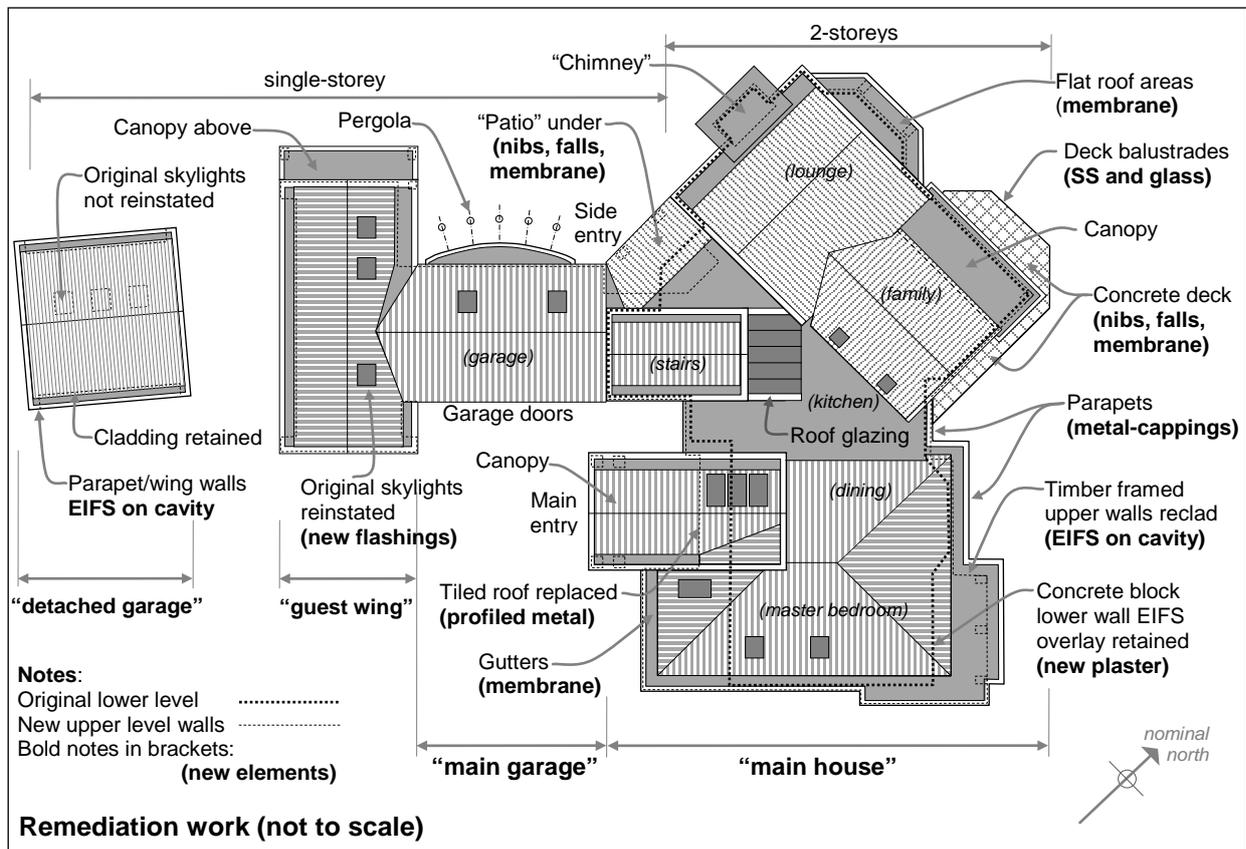
Figure 1: Stage Two of the remediation work
