Determination 2017/029

Regarding the refusal to grant an amendment to a building consent and issue a code compliance certificate for a 16-year-old house with plywood cladding at 433 Pukehina Parade, Te Puke

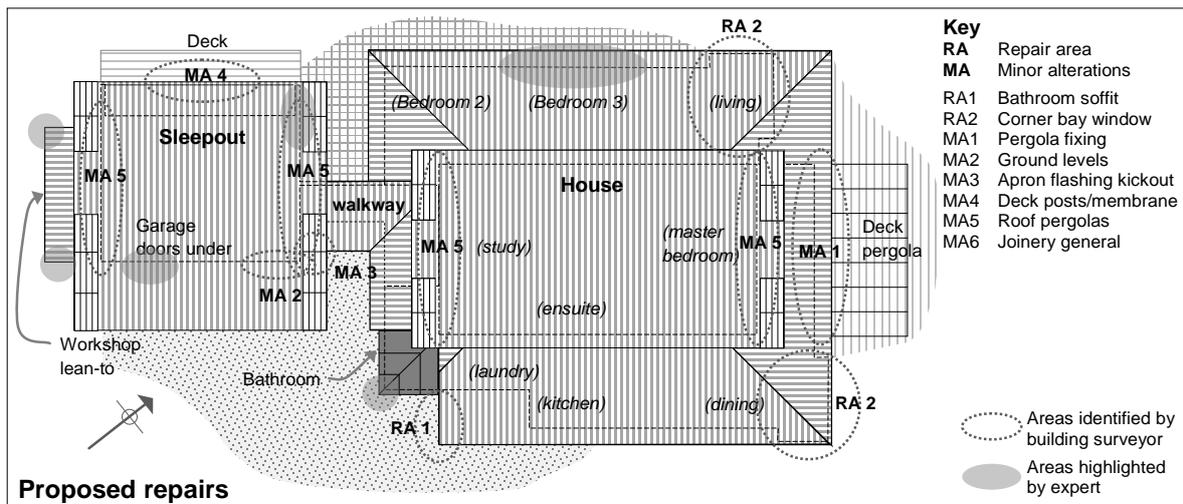
Figure 2: Locations of proposed repairs (not to scale)

| Areas of repair (see Figure 2) | | Expert's comments | Expert's conclusion |
|---|---|--|--|
| RA1 | Laundry soffit framing | <ul style="list-style-type: none"> Lower plywood proud of upper Framing to clad end of soffit decayed No visible sign of damage to lower walls, but framing needs to be exposed to check | Scope of proposed repair sufficient to address defect, but further investigation of the framing below the bulkhead is required to check for damage |
| RA2 | Corner bay windows | <ul style="list-style-type: none"> Cladding removed to expose framing Framing below north window decayed Framing below east window stained No metal flashing under corner cladding Battens were in poor condition, with tops exposed to rain penetration Sill flashing detail still exposes batten tops (I also note battens lack weathergrooves) | Proposed details insufficient Further bay window and corner details required |
| MA2 | Ground levels to east corner of garage | <ul style="list-style-type: none"> Some plywood sheets replaced Sheets fixed hard against concrete slab edge Framing condition not verified Clearances still limited Not in accord with proposed details | Further areas need attention Current repair not satisfactory Scope of proposed repair work is not sufficient to address the defect |
| MA3 | Kick-out to walkway apron flashing | <ul style="list-style-type: none"> End of apron flashing underlaps plywood horizontal flashing | Scope of proposed repair sufficient to address defect |
| MA4 | Membrane to sleepout deck | <ul style="list-style-type: none"> Membrane in good condition except for turn-ups at post penetrations | Scope of proposed repair sufficient to address defect |
| MA5 | Saddle flashings to roof pergola penetrations | <ul style="list-style-type: none"> Exposed ends of beams weathered Some flashings already installed Proposed work allows for investigation of underlying flashing and framing No visual evidence of failure | Scope of proposed repair sufficient to address defect |
| MA6 | Renew joinery jamb sealants, install new jamb battens | <ul style="list-style-type: none"> Timber jamb and sill battens with weathergrooves installed to some windows Sill flashings not installed Sill batten with flat top hard against sill flange Moisture readings to sill low | Proposed details insufficient: Specification, Sill details, Identification of windows to be repaired |

- 6.3.4 In considering the proposed remedial work provided, and taking into account the expert's comments, I am of the view that the repairs proposed (in the drawings dated 3 August 2016) are not adequate to ensure that the repaired building will comply with Clauses B1 Structure, B2 Durability and E2 External moisture.

- 6.3.5 I consider that final decisions on whether compliance can best be achieved by either remediation or re-cladding, or a combination of both, can only be made after further investigation of the cladding and underlying timber framing. This will require careful analysis by an appropriately qualified expert, and should include an investigation of the condition of the underlying framing. Once that decision is made, the chosen remedial option should be submitted to the authority for its approval.
