Determination 2017/052

The refusal to issue a certificate of acceptance for recladding a 22-year-old building at 1/21 and 2/21 Sherborne Street, St Albans, Christchurch

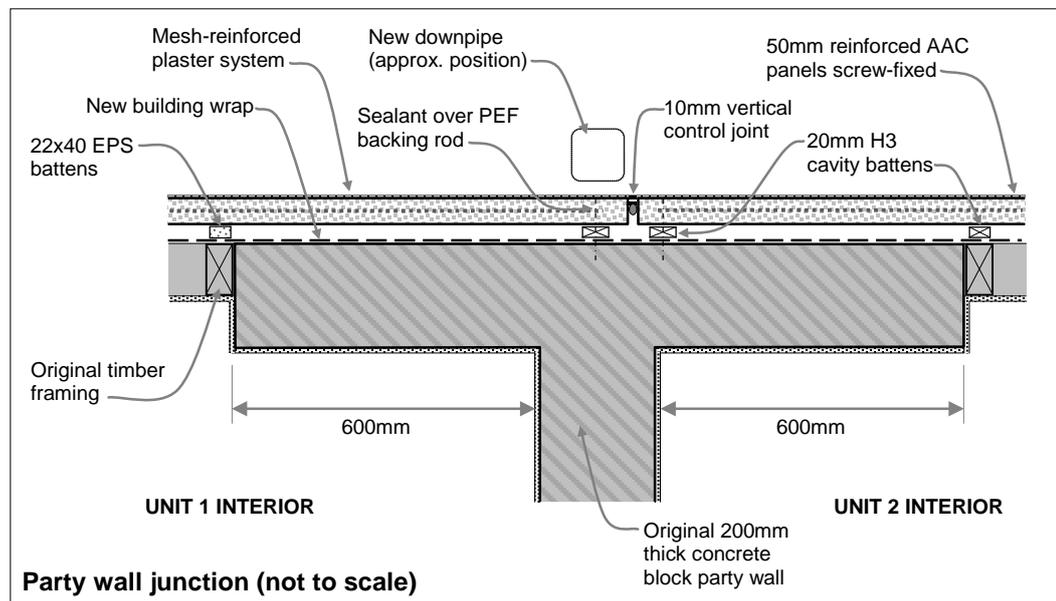
Figure 2: Party wall junction

2.3.3 The manufacturer's 2010 'Technical Manual' ("the manual") set out requirements for vertical and horizontal control joints to be installed in walls exceeding 8m in length and height. Post-installation drawings¹⁰ include a detail of vertical control joints installed only at ends of the inter-party wall. Based on this detail together with the expert's on-site measurement, the as-built party wall junction appears to be as shown in Figure 2.

4.15.1 The authority is unwilling to rely on the builder's producer statement in regard to the party wall detail (see Figure 2), which shows 20mm deep battens in line with the cavity depth instead of 40mm battens as shown in a Ministry guidance detail¹⁶ (Figure 3). The authority requires a fire engineer's report.

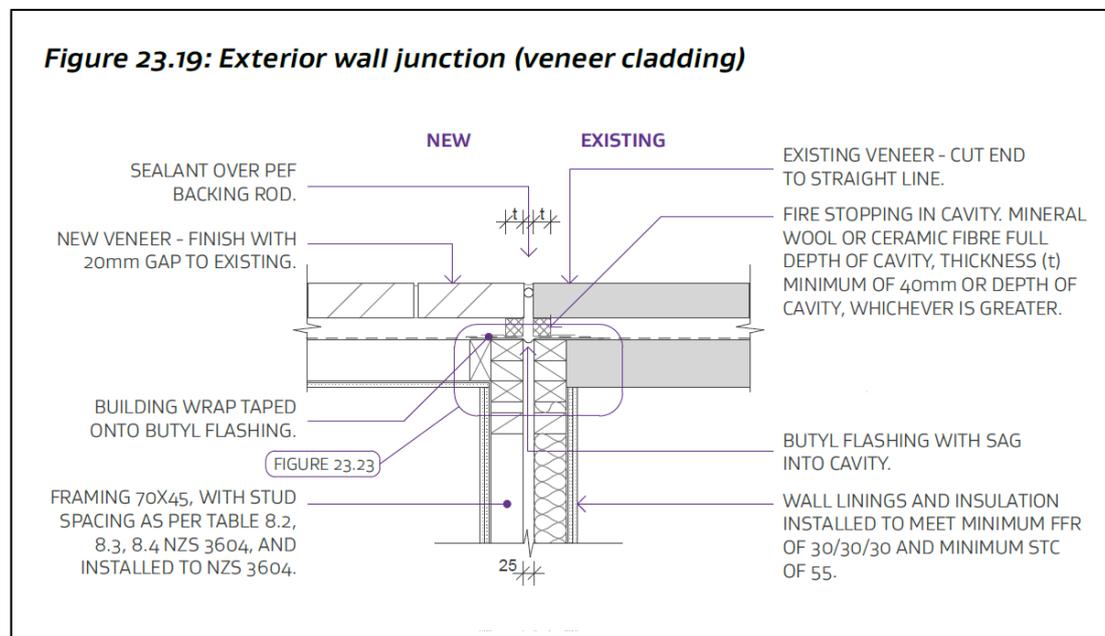
Figure 3: Guidance detail

4.15.2 The expert assessed the party wall, comparing this with Figure 3, and concluded that the as-built fire separation provides at least the same fire separation given that:

- the Ministry detail shows fire stopping in the 40mm cavity installed over flashing tape and a butyl strip, with timber-framing and fire-rated linings either side of the party wall cavity immediately behind
- although the post-construction detail D11 shows the 200mm concrete block party wall extending 400mm into each unit, interior drilling confirmed that the concrete block actually extends 600mm either side of the party wall – so, for a fire to spread between the units, it would have to burn through framing and battens and travel some 1.4m across the exterior of the blockwork.
