Determination 2017/059

Regarding the refusal to issue a code compliance certificate for a 20-year-old house with mixed claddings at 26 Papaunahi Road, Bowentown

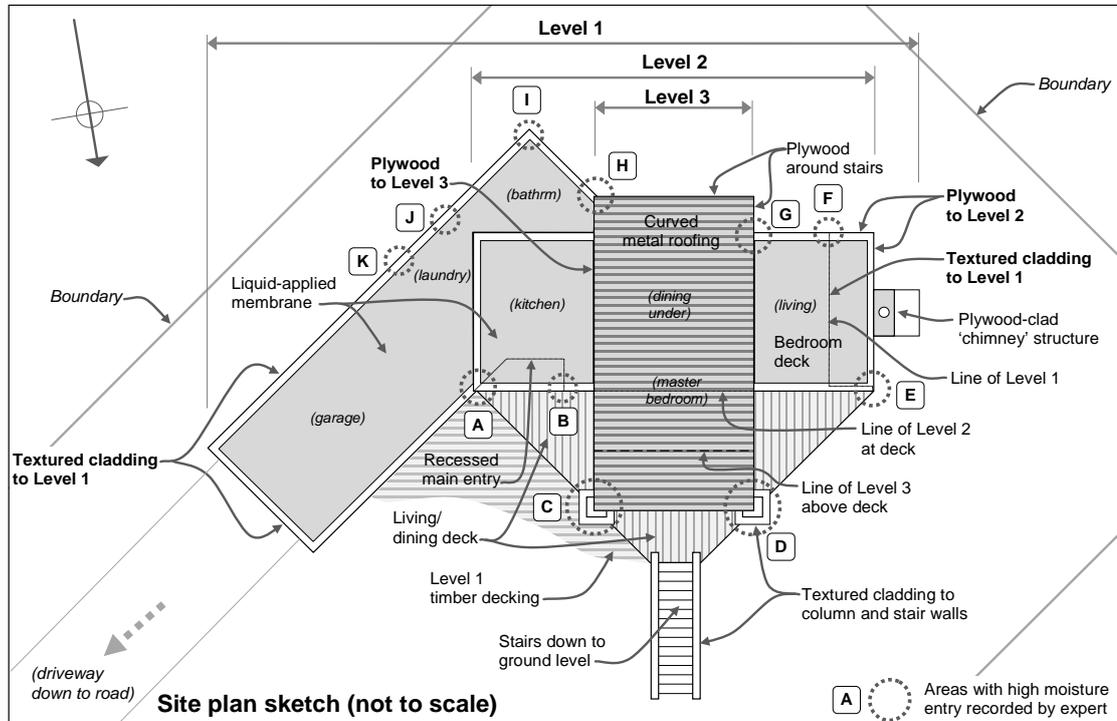
Figure 1: Approximate plan

5.3.2 Taking account of the above and of the high risk features, the expert took 17 invasive moisture readings through the textured cladding. The expert recorded the following readings (refer Figure 1 for location of areas shown in brackets):

- over 80% in deck soffit at garage/Level 2 deck junction (Area A)
- 18% in bottom plate at entry recess under wall/deck junction (Area B)
- 27% to over 80% in east column plinth (Area C)
- 36% to over 80% in west column plinth (Area D)
- 48% to over 80% in the northwest wing wall under living area (Area E)
- 20% in bottom plate to the southwest corner to Level 1 bedroom (Area F)
- over 80% in bottom plate at the southwest textured cladding/plywood junction (Area G)
- 38% in bottom plate at the southeast textured cladding/plywood junction (Area H)
- 33% in bottom plate at south corner of bathroom (Area I)

- 23% in bottom plate at laundry door (Area J)
- 25% to 26% at laundry window (Area K).
