Determination 2017/087¹

The refusal to issue a code compliance certificate for a 19-year-old house with EIFS wall cladding at 184 Adams Road, RD1, West Melton

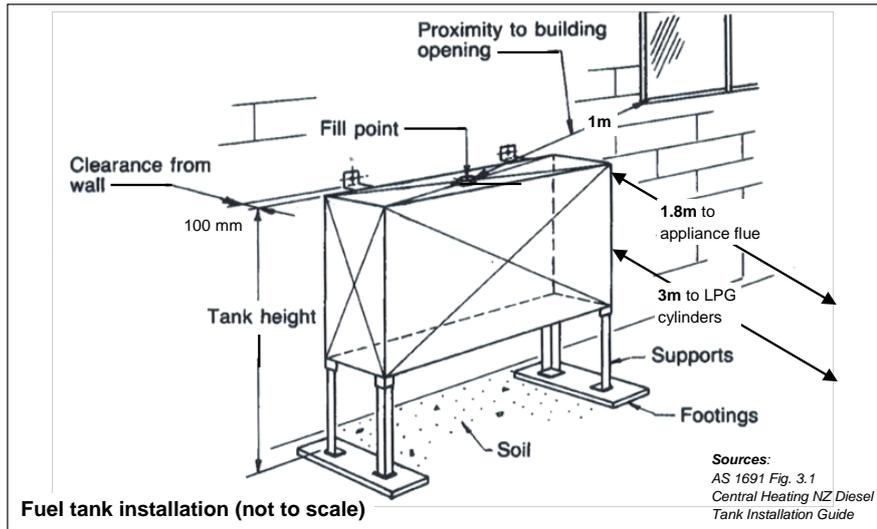
Figure 2: Diesel tank site requirements

6.4.2 In regard to separation distances, including from LPG cylinders, the expert compared the tank siting with the minimum requirements as shown in Table 1:

6.4.3 In regard to the tank installation, the expert noted that (in summary):

6.4.4 The expert’s recommendation was that a concrete foundation should be provided to support the tank.

7.9.3 In regard to seismic restraint of the diesel fuel tank and taking account of the current requirements of C/AS1 Part 7, I note the expert's recommendation is that concrete foundations should be installed, with the tank support legs to be bolted into the concrete in order to provide appropriate long term earthquake resistance. The applicant may wish to consider this step along with the maintenance items that have been recommended (but that are not required to achieve compliance).
