## Determination 2018/003

# The refusal to issue a code compliance certificate for a 13-year-old house with mixed claddings at 707C Great North Road, Grey Lynn, Auckland

### Summary

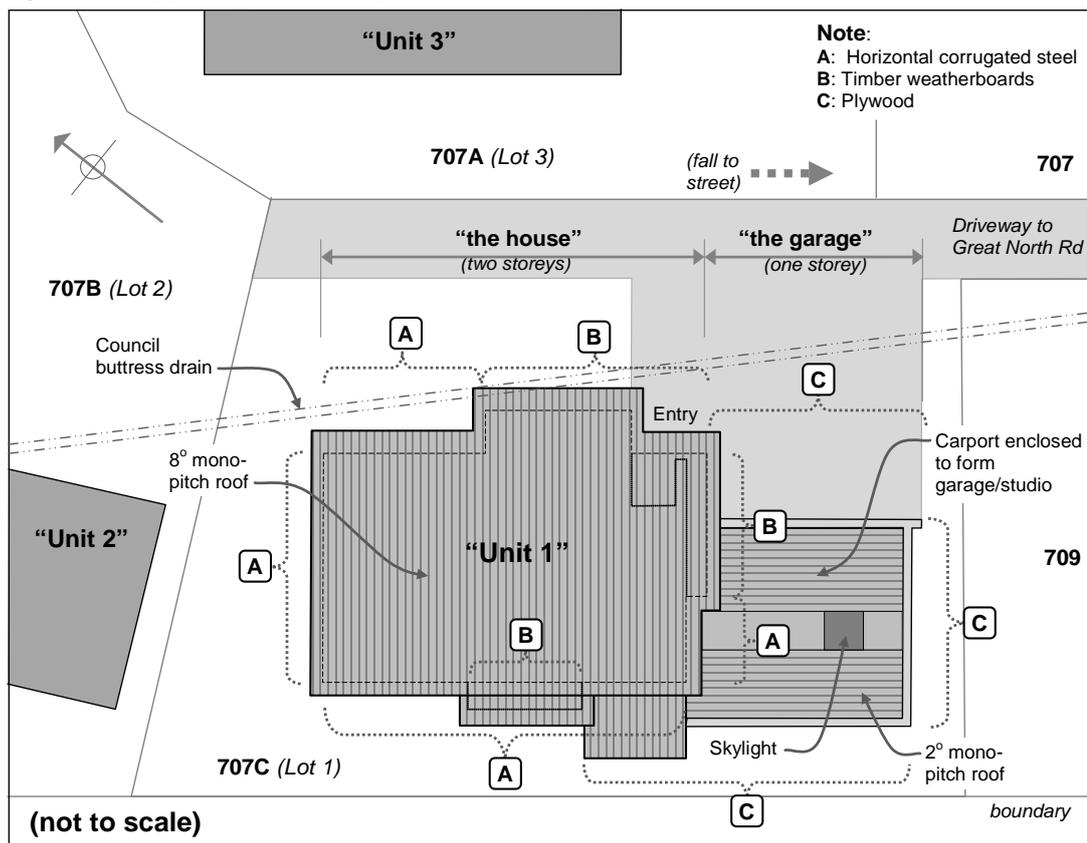
**Figure 1: Approximate site plan**

2.1.4 Construction is generally conventional light timber frame; with specifically engineered timber piles under concrete foundations and floor slab, timber framed upper floor, monopitched profiled metal roofing, aluminium windows and three different wall claddings as shown in Figure 1.

- 2.2.1 The garage walls are clad in plywood fixed through the building wrap directly to the framing timbers (cladding “C” in Figure 1). Timber battens are fixed over vertical joints, with a metal flashing over the horizontal joint.

- 2.2.2 The wall cladding to the east corner and to the southwest projecting bay is horizontal bevel-backed timber weatherboards (cladding “B” in Figure 1), fixed through the building wrap directly to the framing timbers. Timber facings frame the windows, with flashings over head facings, scribes to jamb facings and a sloped top to sill facings.

- 2.2.3 The remaining walls of the house are clad in horizontal corrugated steel (cladding “A” in Figure 1) fixed through the building wrap directly to the framing timbers. Proprietary folded metal flashings are installed at corners and other junctions. Flat riveted steel sheet form ‘facings’ around windows and doors, with metal head flashings underlapping head facings.

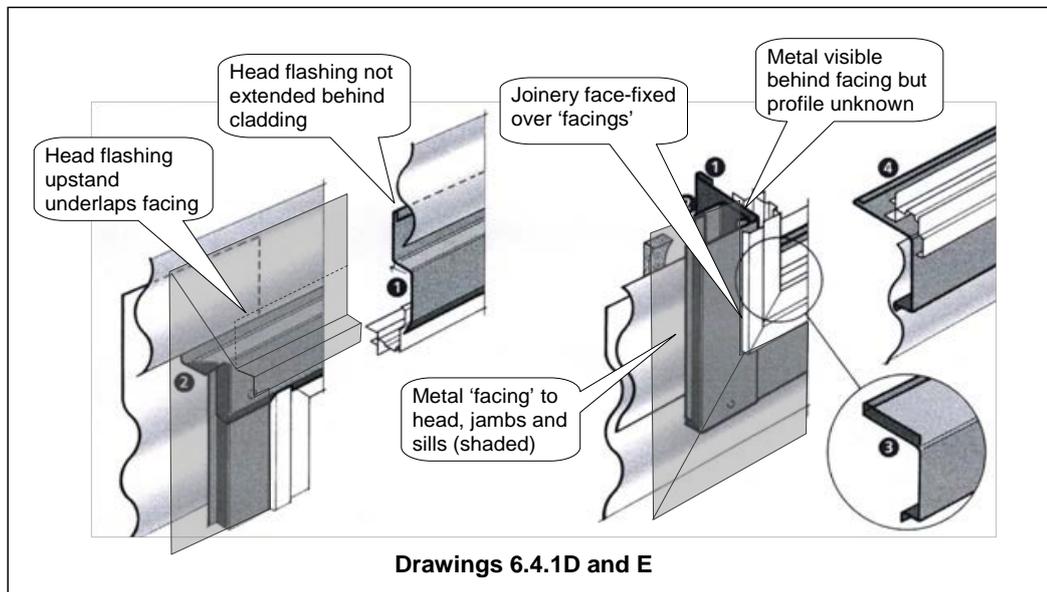
### A.1 Annotated Figure 2 from NZ Metal Roofing Manufacturers Inc.: Metal Roof and Wall Cladding Code of Practice; Version 2.2, 2012.

5.6.2 The expert noted that E2/AS1 does not include comparable window details and therefore referred to the NZMRM<sup>12</sup> Code of Practice (see Figure 2 in Appendix A) in order to assess the windows as-installed.

- metal ‘facings’ provide trim to window heads, jambs and sills, with joinery face-fixed over the facings and no sealant at the flange overlap
- head flashings underlap facings but do not extend behind the cladding
- although a metal flashing is visible at jambs<sup>13</sup>, it is not possible to determine whether the flashing is folded behind the cladding
- the four invasive moisture readings below joinery in corrugated steel walls ranged from 12% to 15%, indicating adequate current performance
- testing of Samples 2, 5 and 6 from sill trimmers found no fungal growth after 13 years in service indicating adequate past performance (with the traces of yeast indicating a transfer of condensation from the back of the metal)

5.6.4 Notwithstanding the above, the expert recommended as part of normal maintenance improving the weathertightness of joinery installation by:

- sealing junction between the joinery jamb flanges and metal ‘facings’
- reinstalling missing clip-on retaining extrusion to northwest ranchsliders.
