Determination 2018/019

The code-compliance of the base of a wall to a large shed containing a dwelling at 122E Forestry Road, Waitoki, Auckland

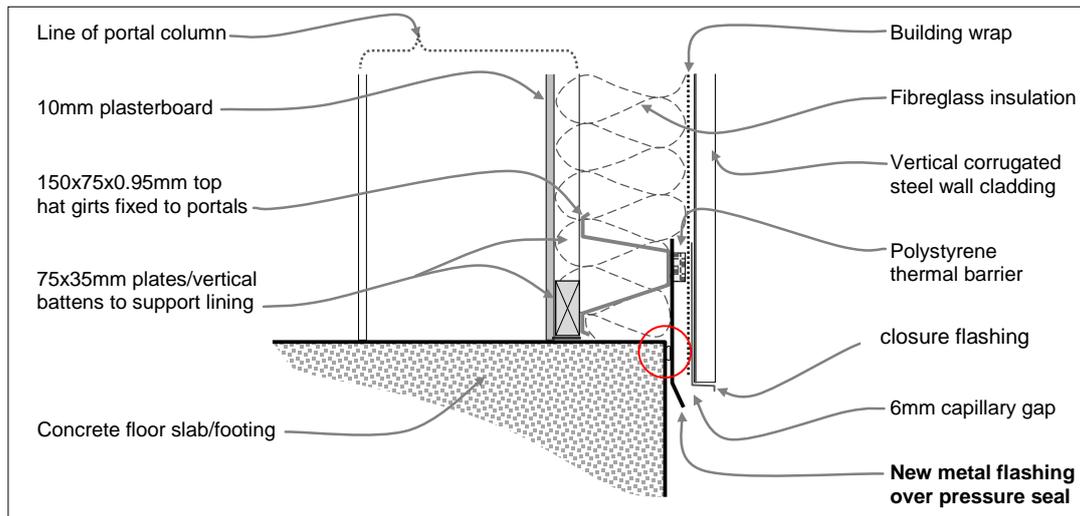
Figure 4: The approved remedial base flashing detail (not to scale)

- 2.3.2 The hand-drawn detail of the additional flashing on drawing 19/9 (shown in Figure 4 as “new metal flashing over pressure seal”) is stamped as approved by the authority on 6 November 2017 and has the title (emphasis added):

- 2.3.3 The new metal flashing (“the base flashing”) was designed to provide a 6mm capillary gap between the base flashing and the existing closure flashing.

- 2.3.4 The pressure seal is a 3mm thick closed-cell PVC foam with pressure sensitive adhesive on one side. The seal is fixed with the adhesive to the additional flashing and the location of the flashing holds the seal against the concrete slab. According to the manufacturer, the foam is sold for use in automotive, marine, industrial, and construction applications.
- 2.3.5 In addition to the above, the remedial work included provision of a sill flashing to the two personnel doors with a spring-loaded proprietary weather seal to the base of the doors which closes against the sill flashing.

4.2.3 I consider the detail referred to by the parties contained in E2/AS1 (Figure 93) has a limited application to this situation (refer Appendix A.4). Figure 93 only addresses the likelihood of capillary action drawing water up between the concrete slab and the rear of the cladding to the bottom plate. The bottom plate and closure flashing in Figure 93 is, in effect, providing a sealed air path above the top of the slab.

4.2.4 In the subject building, moisture-laden air is able to be drawn up under the base of the cladding and onto the concrete slab. There is no form of pressure equalisation to help prevent moisture-laden air being drawn into the building. While there has been an emphasis on avoiding the effects of capillary action, I do not consider this is the principle means by which water will enter the cladding at this point.

- The gap between the base flashing and the closure flashing is reduced at the base of these two flashings: the thermal barrier will in effect form an air seal between both flashings. The gap between the two flashings itself would not have given any rise to capillary action.

- The base flashing extends some 80mm below the concrete slab. The bottom kickout to the base flashing minimizes capillary rise behind the flashing.
- The closed-cell foam seal behind the base flashing will reduce air and moisture movement into the wall space. The closed-cell foam itself will not allow the passage of water, i.e., water will not be drawn through the foam.

- However, the foam is only 3mm thick. This may not be thick enough to allow for construction tolerances in the relative location of the bottom girt and the edge of the concrete slab, and for variations in the slab edge itself. The proximity of the base flashing to floor slab along the length of the slab needs to be verified on site.

4.2.6 In principle, the remedial base detail will provide a solution that will meet the performance requirements of Clause E2. However, the location of the base flashing relative to the edge of the concrete slab should be verified onsite to confirm the effectiveness of the foam seal. The assessment might be done by carefully probing this junction at sample points to test for any gap.
