Determination 2018/030

Regarding the compliance of Lawson Cypress posts to a portico roof at 19 Royal Ascot Drive, Papamoa Beach, Papamoa

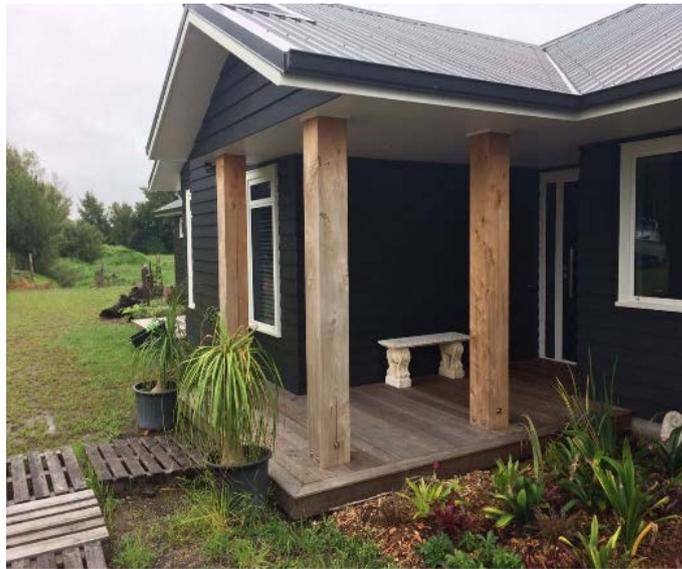
2.2 These portico support posts are Lawson Cypress 250mm square posts. The timber supplier has confirmed the timber posts were 'heart Lawson Cypress to the NZS3602^[4] grade'. Each post is supported by a stainless steel bracket embedded into a concrete footing. Two M12 bolts run through each post to connect it to the bracket. A third bolt runs through each post on the adjacent faces. The base of the posts is approximately 190mm above ground level (110mm from the concrete footing to the base of the post).

2.3 The deck consists of a timber structure and decking, and sits close to the ground. The timber joists appear to abut the base of the posts, with no gap apparent. Based on the photographs supplied, the timber decking is laid with a small gap present around the posts.

- 3.3 The authority also provided two photographs of the posts. Checks are visible in the centre of two posts where the post is bolted to the bracket. One of the checks appears to run approximately three-quarters the length of the post.

- Although the vertical posts will shed water, the checks in the timber form areas where water can be trapped or that are unable to dry out.
 - There is no evidence the cut ends have been treated with a surface preservative, and the checks are unlikely to be able to be adequately treated with a surface preservative.

- The decking is laid around the base of the posts. The size of the gap between the decking and the posts is not clear. The timber deck joists and related structure appear to abut the base of the posts. Water will collect on the decking around the post, and where the joists abut the posts underneath the decking.

- 5.1 In accordance with section 188 of the Building Act 2004, I hereby determine the portico support posts do not comply with Clause B2.3.1(a), and accordingly, I confirm the authority's proposed exercise of its power of decision to not issue the code compliance certificate on that basis.
