Determination 2018/034

The refusal of a code compliance certificate for an addition at 42 Harley Close, Hauraki, Auckland

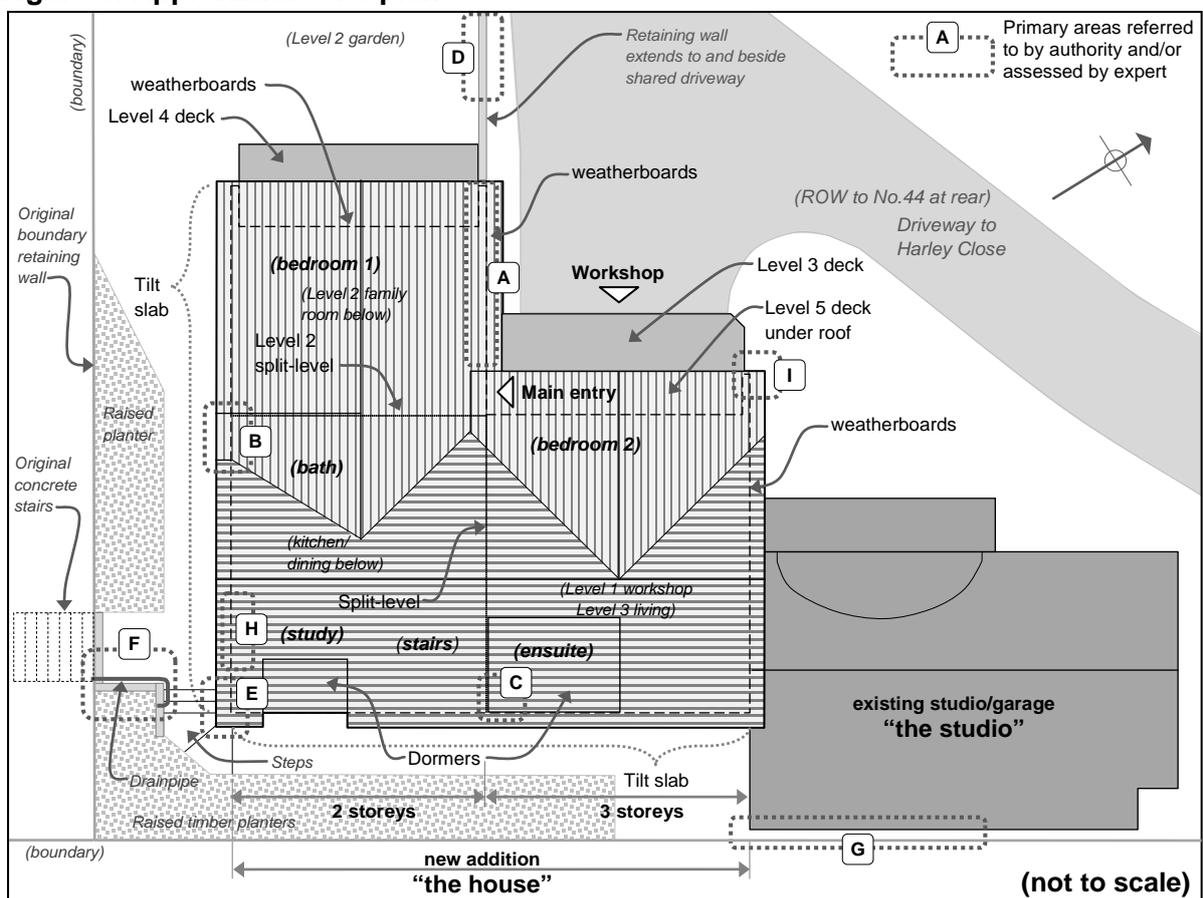
Figure 3: Approximate site plan

2.3.1 The house addition occupies the wide end of the site at the southwest end of the studio as shown in Figure 3. The house addition more than triples the original area. It is fairly complex in plan and form and is assessed as having a moderate to high weathertightness risk.

2.3.2 As shown in Figure 3, the house addition provides a multi-level building that has five main levels as follows:
