Determination 2018/038

Regarding the refusal to issue a code compliance certificate for a 10-year-old house with mixed claddings at 27 Terrace Avenue, Mount Maunganui, Tauranga

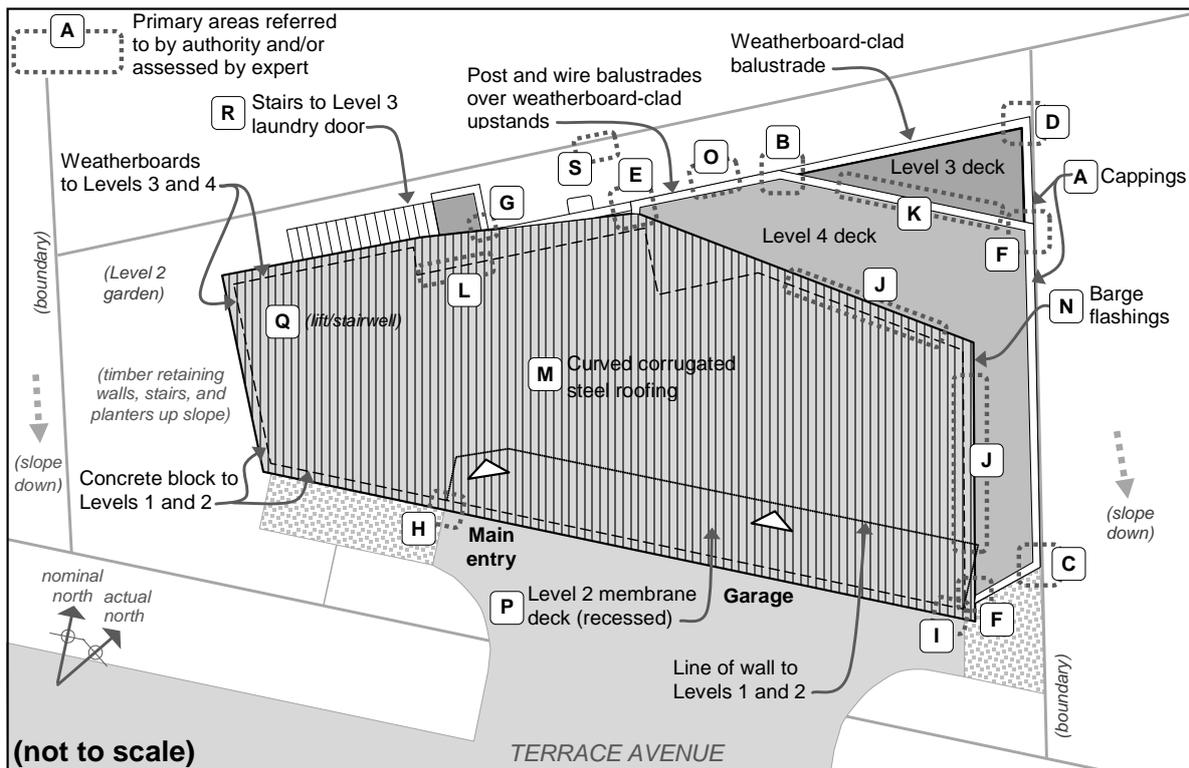
Figure 1: Approximate site plan

3.4.2 In regard to weathertightness (Clauses B2 and E2), the authority listed items requiring attention (in summary using the authority's references and with typical areas shown in Figure 1 provided in brackets):

1. Lack of kick out to balustrade cappings (Area A)
2. Deck outlets and overflow provisions (Area B, C and D)
3. Lack of rainwater heads (Areas B, C and D)
4. Balustrade/wall junctions (Areas B, E, F, G, H and I)
5. Head flashing/weatherboard junctions (Areas J, K, L)
6. Roofing durability (Area M)
7. Overflow to rainwater head (Area E)

- lack of overflow to Level 3 deck (Area D)
- lack of rainwater heads to Level 3 and Level 4 decks (Areas B, C, D)
- cracked capping junction to Level 3 deck (Area B)
- corroding roof fixings and barge flashings (Areas M,N)
- lack of overflow to rainwater head (Area E)
- insufficient height of handrails to interior stairs (Area Q).
