## Determination 2018/046

# Regarding the refusal to issue a code compliance certificate for alterations to a 16-year-old building at 176 McLeod Road, Te Atatu South, Auckland

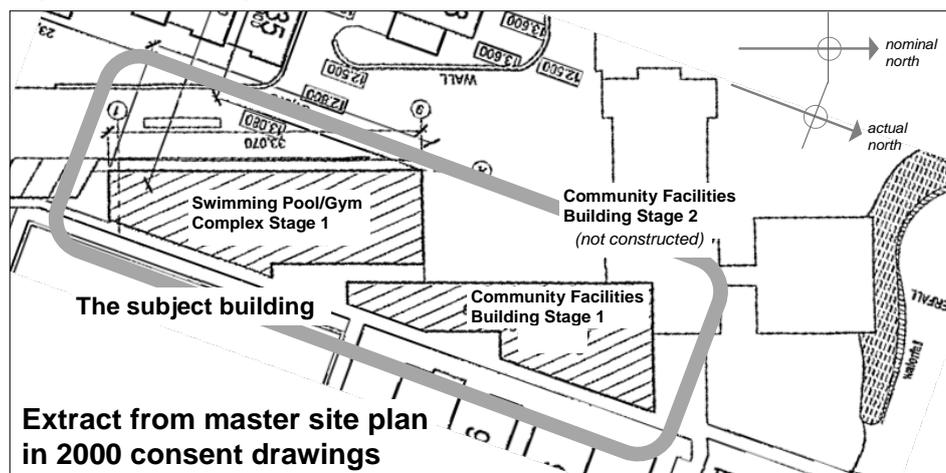
**Figure 1: The original facilities complex (not to scale)**

- 2.2.1 The original building was constructed in 2001 in the form of two separate buildings linked with a covered walkway as shown in Figure 1:

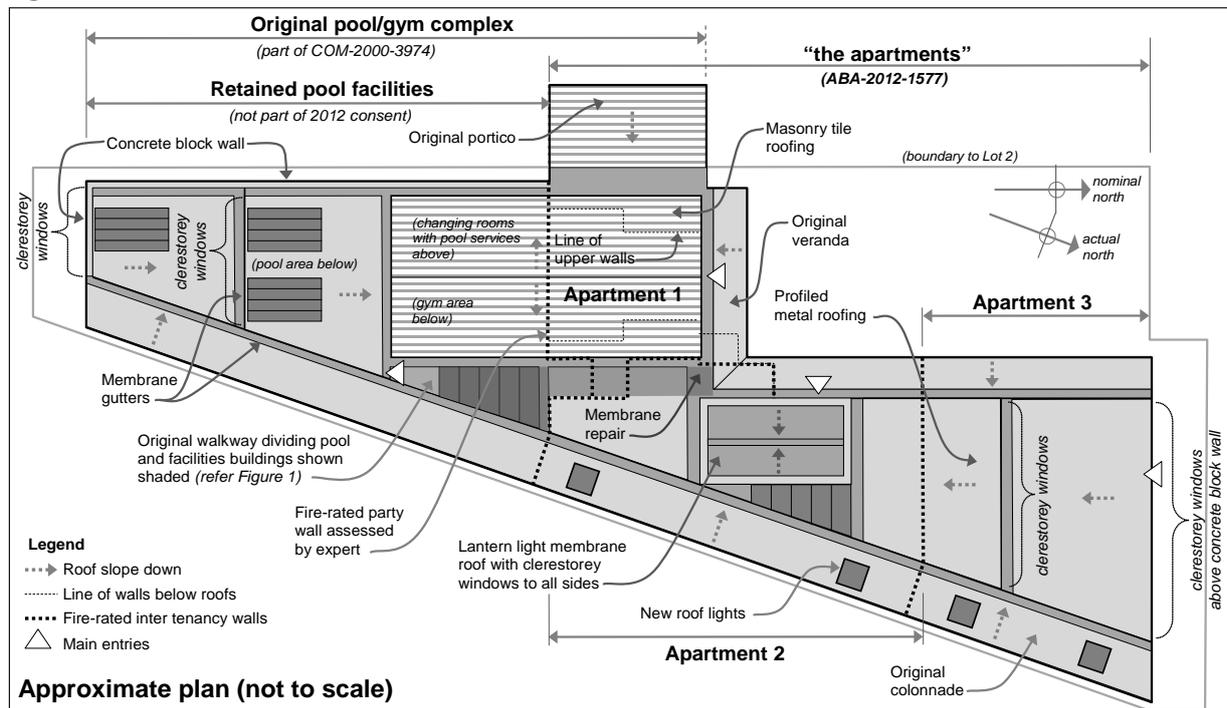
**Figure 2: The 2012 alterations**

5.3.2 In regard to previous roof repairs above the Apartment 1 to 2 junction (see Figure 2), the expert noted that:

- the repaired area is small and there is minor ponding to an adjacent area
- there is no information on the reason for the repair, so it is unclear whether work would have been exempt under Schedule 1 from requiring a consent

- prior to the alterations, the area was an open walkway and any leak would have penetrated into the walkway soffit
- the walkway soffit was removed as part of the 2013 alterations and new walls passed pre-line and framing inspections (see paragraph 3.3.4)

- any leaks in flat roof membranes are commonly quickly visible below and there are no current signs of any moisture penetration into new ceilings
- the first final inspection on 1 April 2016 was some two years prior and this also did not identify any signs of any moisture penetration into underlying ceilings

- taking account of the above, any prior leak therefore appears to have been adequately repaired and has performed to date.
