## Determination 2019/007

# The refusal of a code compliance certificate for 18-year-old additions and alterations to a house at 26 Day Dawn Crescent, Omaha, Auckland

### Summary

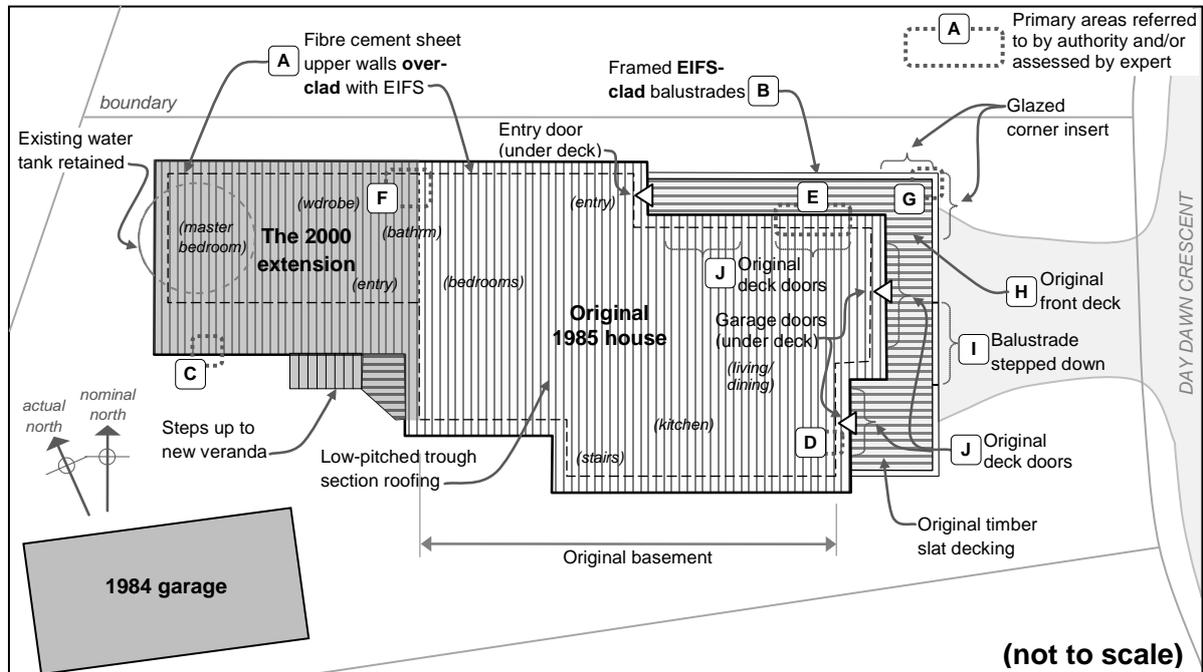
**Figure 2: Approximate site plan**

Section 95A notice dated 9 February 2018 (in summary)		Fig.2 Area	Comments	Para-graph	Compliance
1a)	Extension over clad	A	<ul style="list-style-type: none"> <li>• No evidence of current or past moisture penetration.</li> <li>• Wall cladding has performed for more than 15 years.</li> </ul>	4.3.1	Compliant
2a)	Smoke alarm location		<ul style="list-style-type: none"> <li>• Smoke detectors not required by the Building Code at the time of the consent was issued.</li> <li>• Several detectors located within dead air zones – contrary to current requirements.</li> </ul>	4.3.2	Cannot be enforced as a requirement of the consented work.
